**ORIGINAL HOME
INSPECTION
SUMMARY**

245 W Jewett Blvd, White Salmon WA
98672
Marla Keethler
October 29, 2021

Steve Gibson
Certified Real Estate Inspector Since 1998
InterNACHI 12041805 | Washington #
379 Oregon # 76 - Licensed Construction
Contractor # 129290
Buyers & Sellers Home Inspection Service

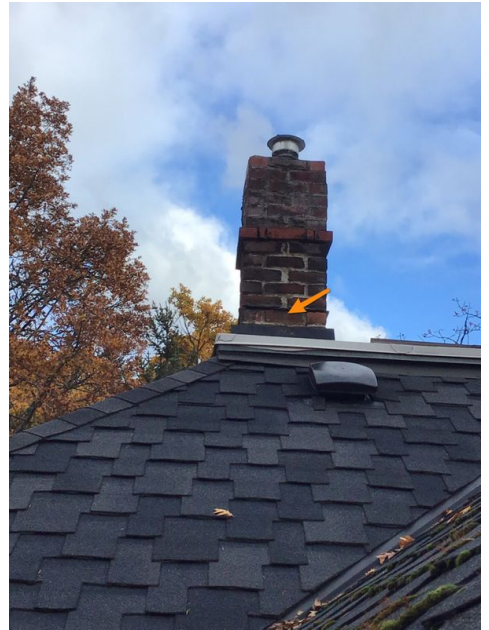
CHIMNEY REPOINT NEEDED

Joints in the masonry have deteriorated and should be repointed. (Repointing is the restoration of the mortar joints in the masonry). Suggest a masonry professional review the homes masonry systems for a final determination of attention needed.

Contact a qualified chimney contractor.

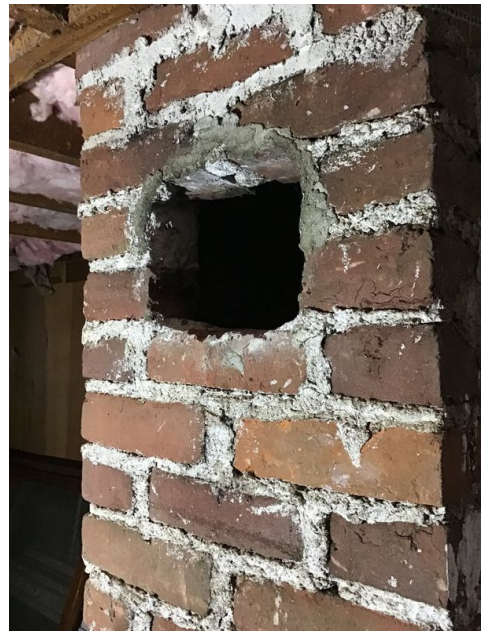
2.1.3 Chimneys, Vents & Roof Penetrations
**SEALING OPENING IS SUGGESTED IN
BASEMENT**

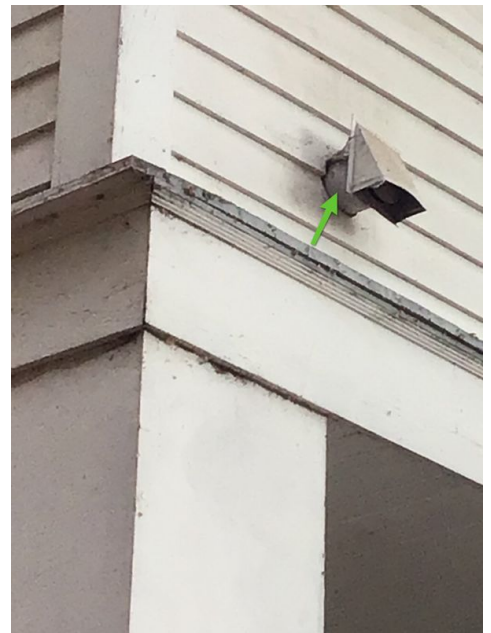
There was some holes seen in the siding and trim where pests could get into the home it would be recommended to seal these openings.

Contact a qualified professional.

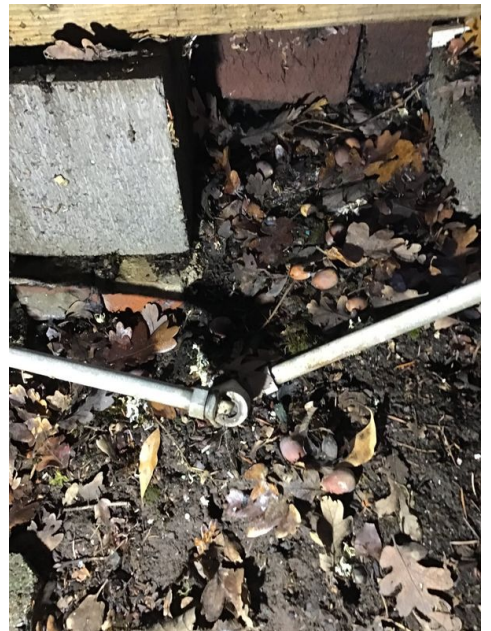
3.7.1 Electrical & GFCI's
ELECTRICAL DEFECT

I observed indications of an electrical defect at the exterior. Damaged wiring conduit in areas - and not secured.

Contact a qualified electrical contractor.

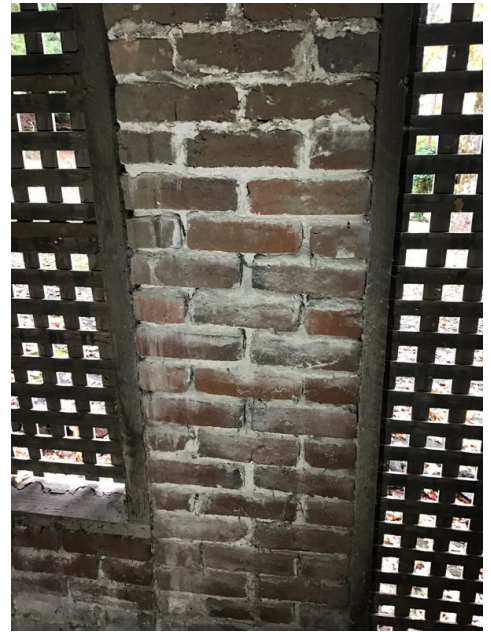
East

3.10.1 Foundation **BRICK WORK FOR TUCK POINT REPAIRS** Recommendation

Some exposed brick areas below the E side porch need attention. Suggest a masonry contractor review these areas for a final determination of attention needed. This brick work is likely the construction method used to build the porch support systems covered with a smooth cement layer / covering at sometime in the past.

Recommendation
Contact a qualified professional.

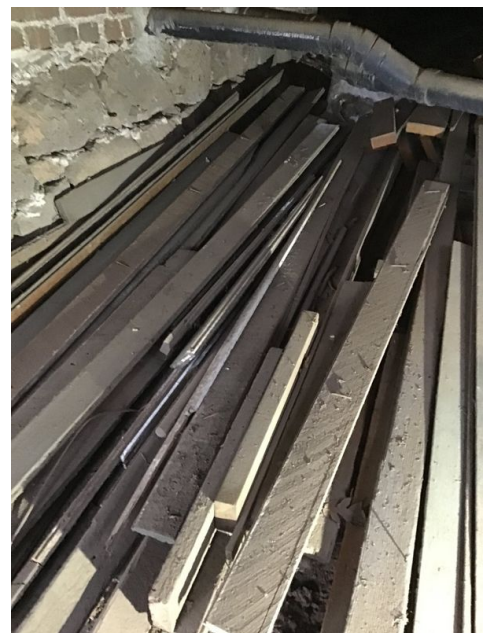
North

3.10.2 Foundation **WOOD DEBRIS FOR REMOVAL TO GARAGE** Maintenance

Noted under the N porch area.

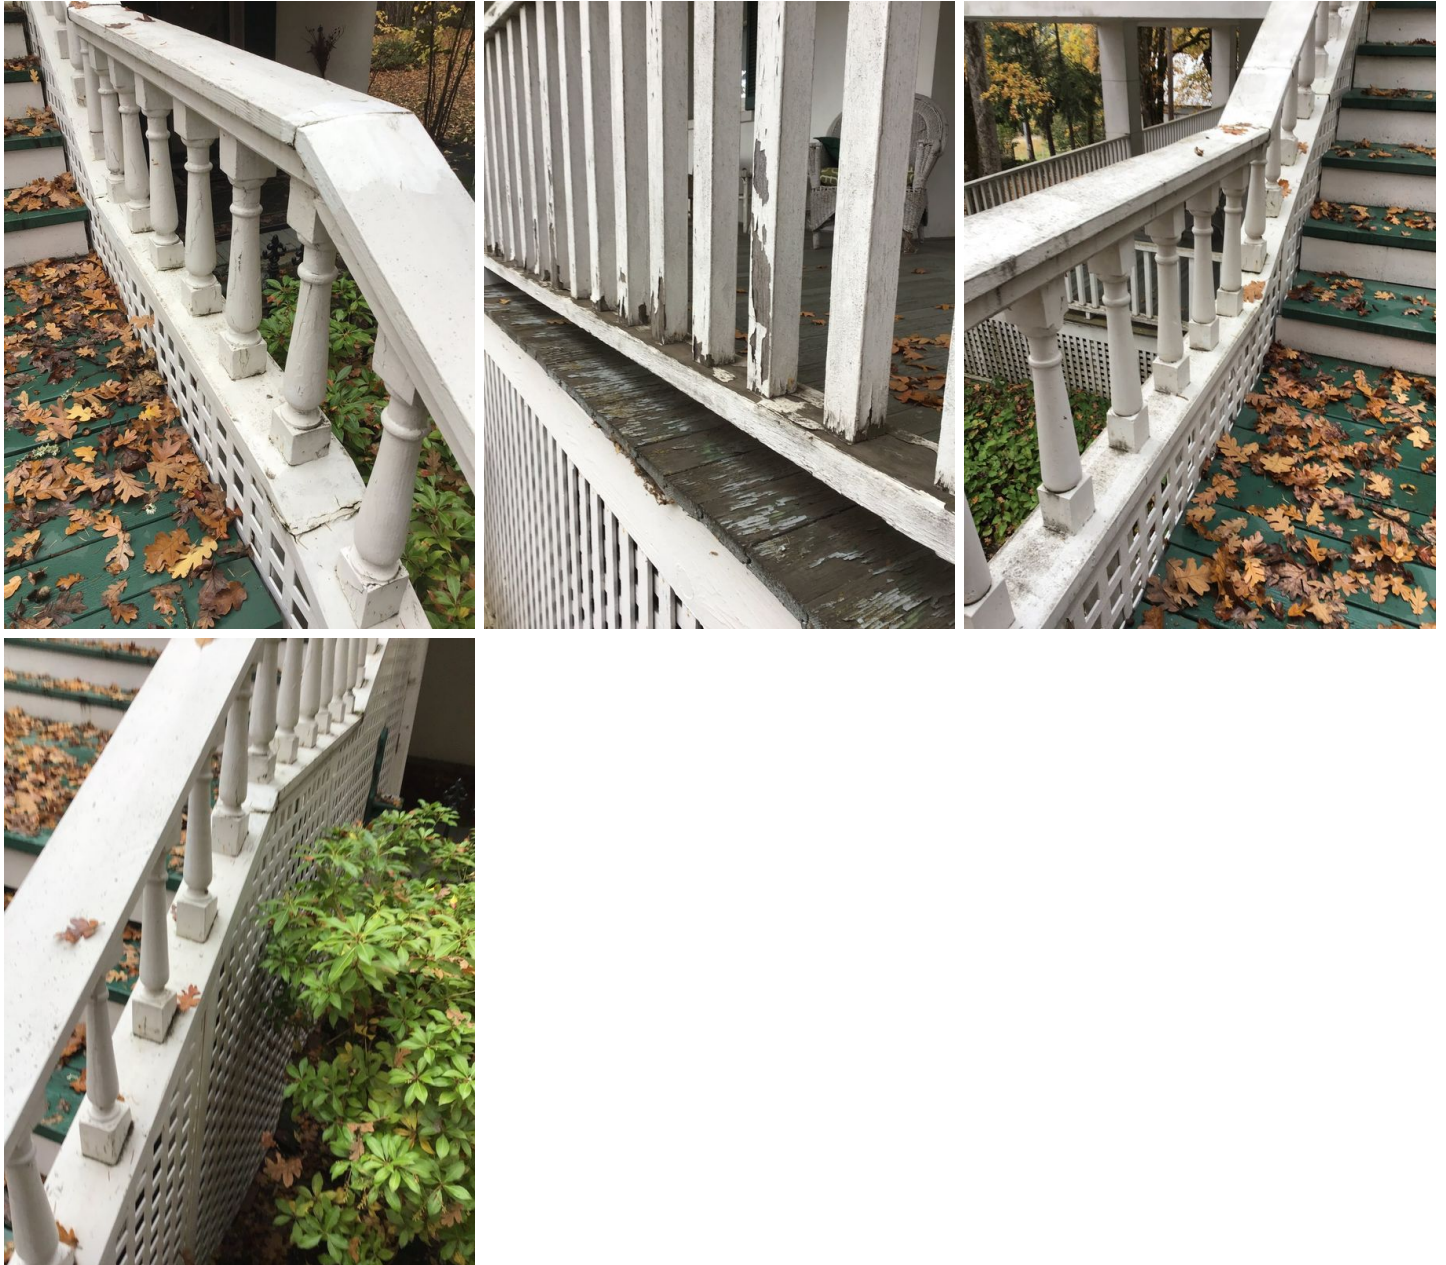
DETERIORATED CONDITION AT FRONT STEP SIDE RAILINGS.

I observed indications of deteriorated and aged conditions at the deck components. The side railing are NOT secured fully to the main stair system it appears. They were noted to move with ease when pushed upon. The smaller rear stair system has limited side hand railings and pickets and supports.

Contact a qualified deck contractor.

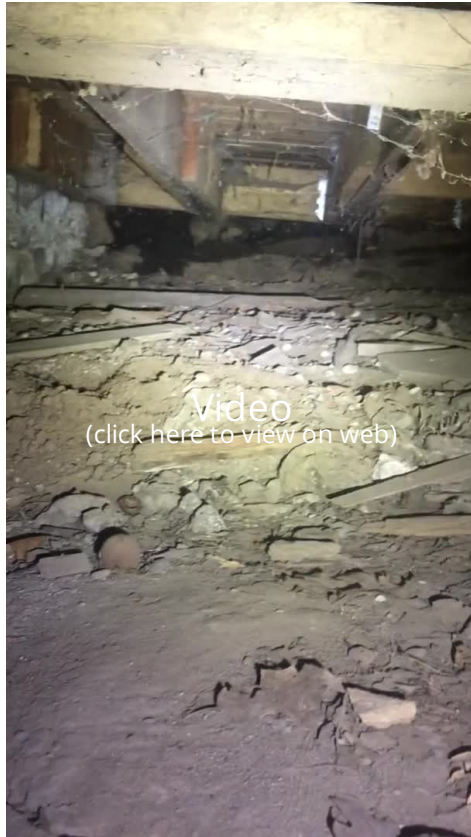
Framing members for the deck are either in or very close to the soil, the material does not appear to be pressure treated or naturally decay resistant- recommend repair. If not corrected- overtime the wooden members will decay.

Areas noted in contacts with soils and or needing updated support work include -

1. Areas below the wood steps at the N side- Lower level steps. See prior pics.
2. Two wooden supports were noted in contact with soils under the lower height NW porch area near the lower level N side door. Past repair were noted. (Some newer wood with metal brackets)
3. Areas adjacent to this area of the wood porch are in contact with rock and soils it appears and will require ongoing attention.

Contact a qualified professional.

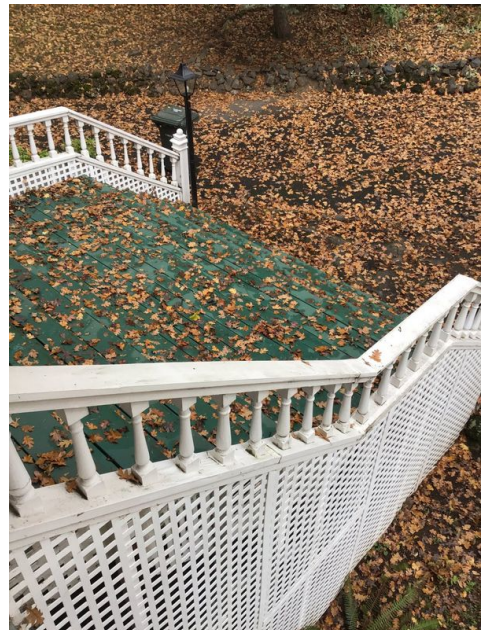
GUARD RAILING LOOSE / LOW IN HEIGHT-

Guard railing was loose recommend repair by a licensed carpenter. Noted to move when leaned upon. Updates are needed for occupant safety. See prior notes.

Contact a qualified deck contractor.

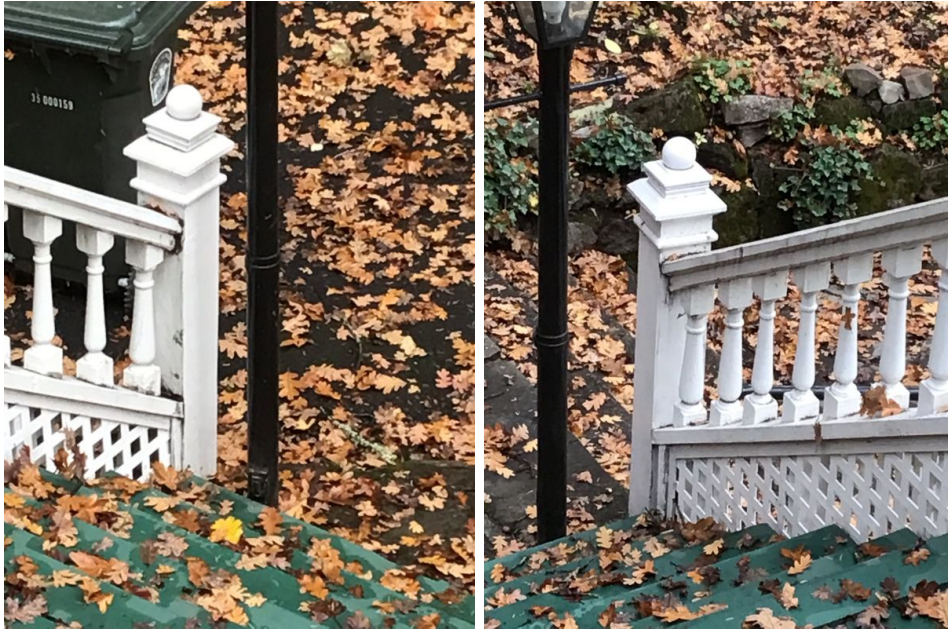
LOOSE PORCH POST

The post installed on the porch is loose recommend further review and repair by a licensed general contractor.

Contact a qualified general contractor.

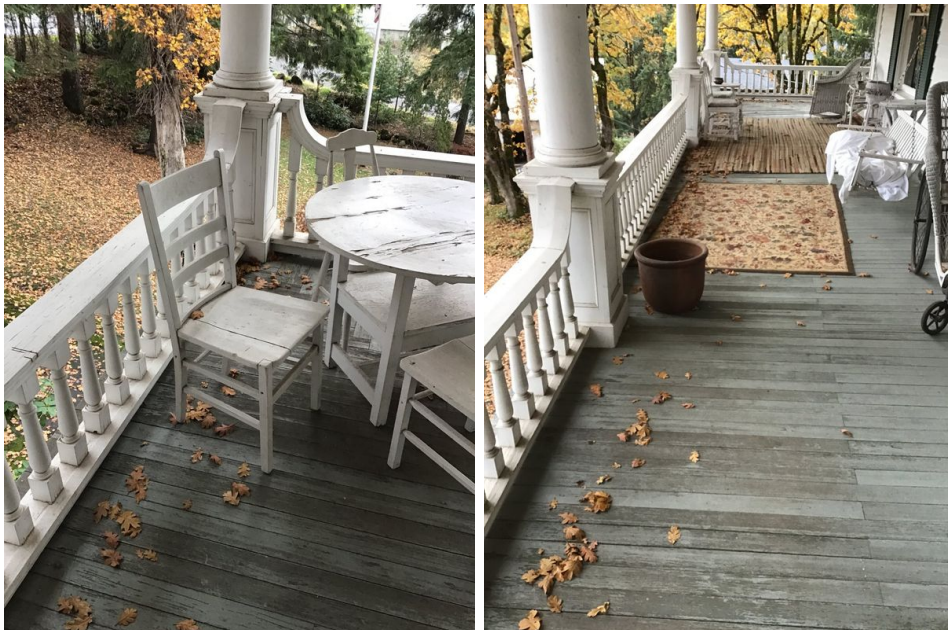
IMPROPER GUARDRAIL HEIGHT (NOT 36")

I observed indications of a defect related to the height of a guardrail.

Contact a qualified carpenter.

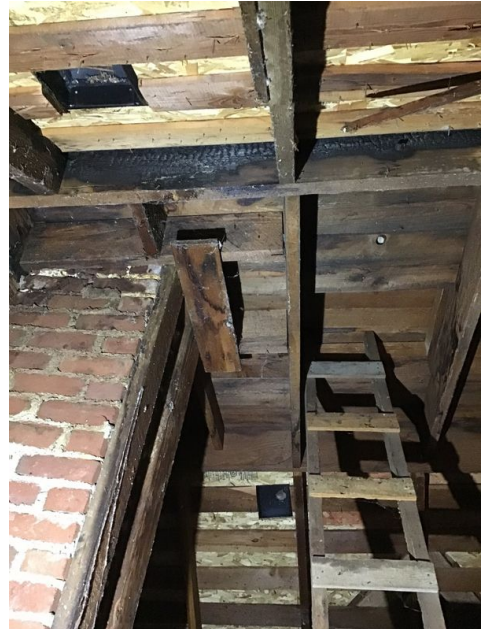
PAST FIRE INDICATIONS NOTED

Confer with the seller and or the local fire official for information about the past history of a fire(s) in the home. The amount of charred or replaced newer wood appears limited.

Contact a qualified professional.

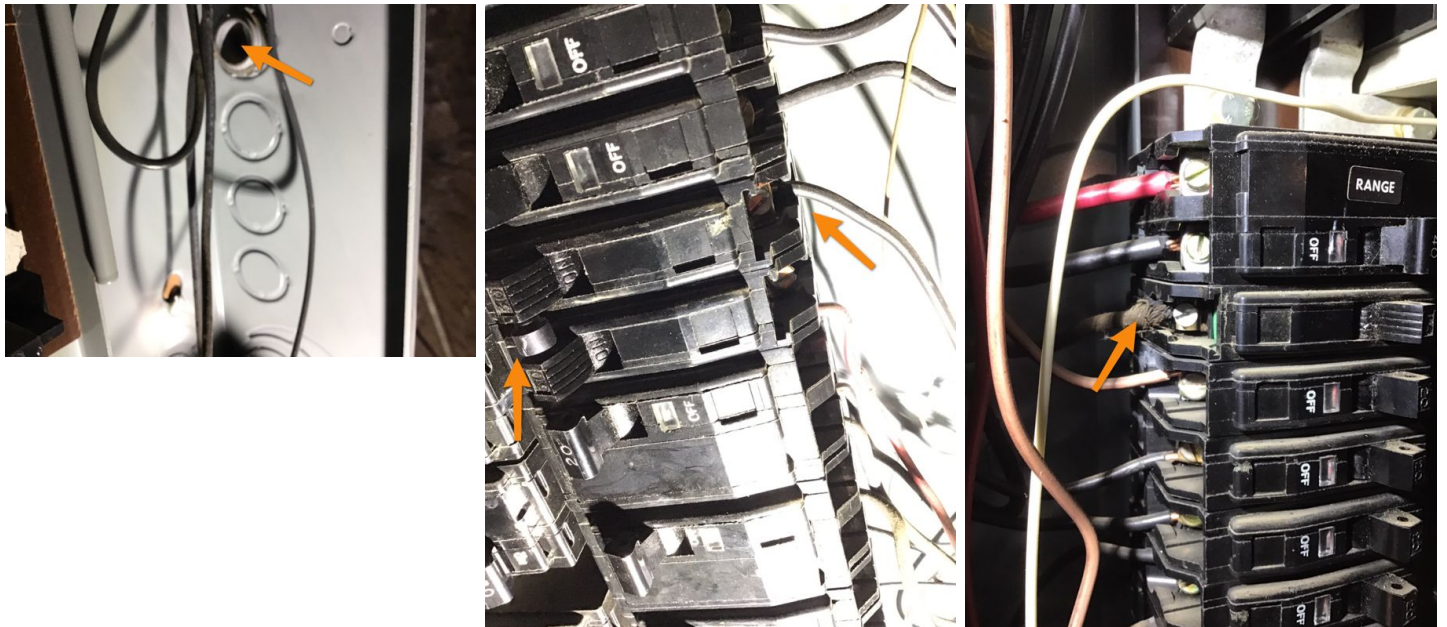
1. A single wire was noted on a two pole breaker. Correction is warranted.
2. The now closed pool breakers are still in the on position.
3. A side knock out covering is missing.
4. An aged cloth covered wire was noted in the panel for consideration of updating.
5. Limited labeling noted on the panel and aged FUSE panel in the attic- Updates are needed for safety.

Contact a qualified electrical contractor.

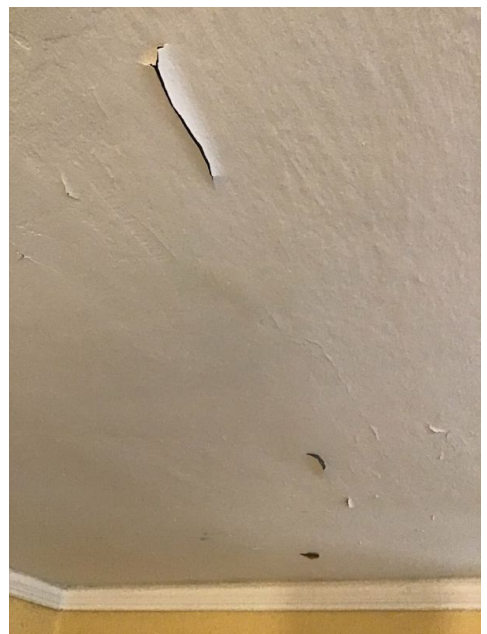
CRACKING

There was some minor cracking in the hallway ceilings and the lower bathroom ceiling. Given the age of the home this structure appears to have had limited visible updates and repairs due to shifting or movement within the structure.

Contact a qualified professional.

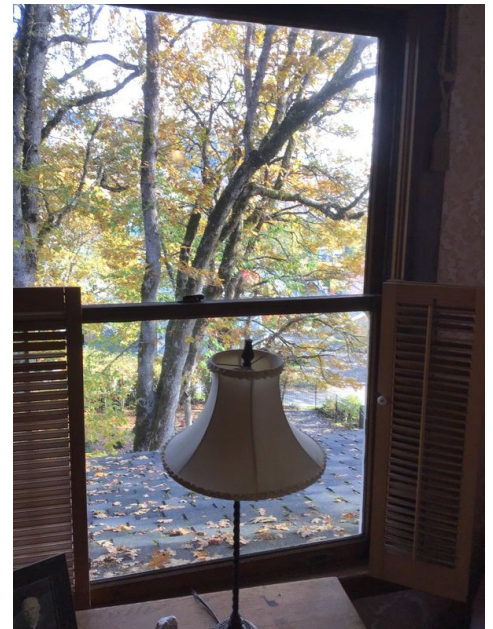
Southeast and Northwest

Window is difficult to operate recommend review by a licensed window contractor.

Recommendation
Contact a qualified window repair/installation contractor.

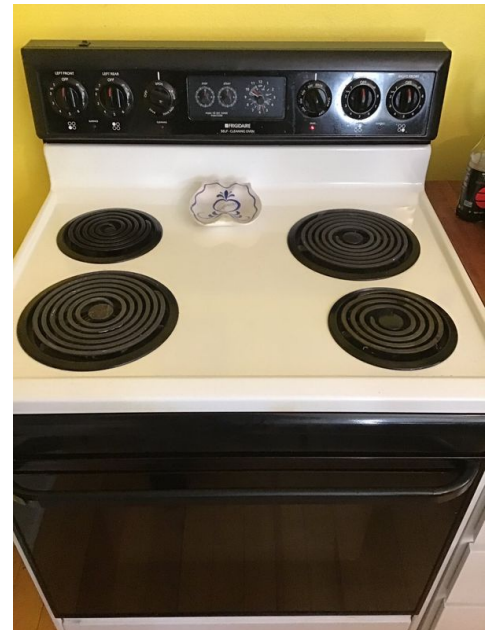
MISSING GFCI PROTECTION

I observed indications of missing GFCI protection in the kitchen. All kitchen counter receptacles are required to be GFCI protected.

Contact a qualified professional.

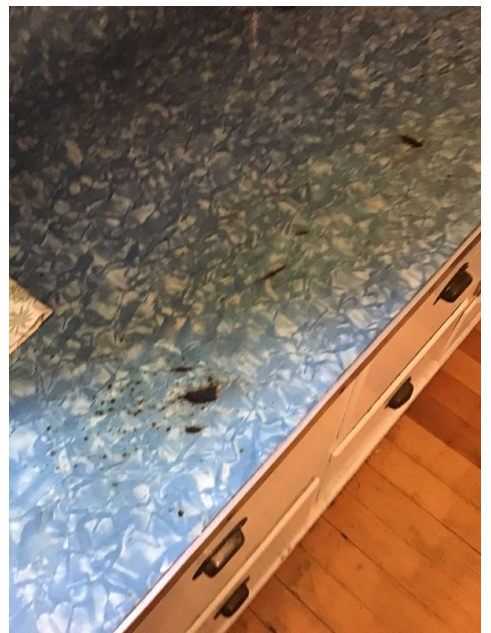
WORN AREAS AT COUNTERTOPS

Recommend monitoring.

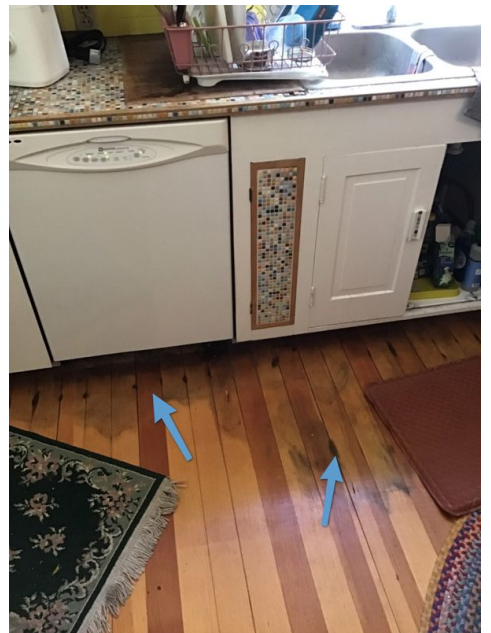
MOISTURE DAMAGE

Contact a qualified professional.

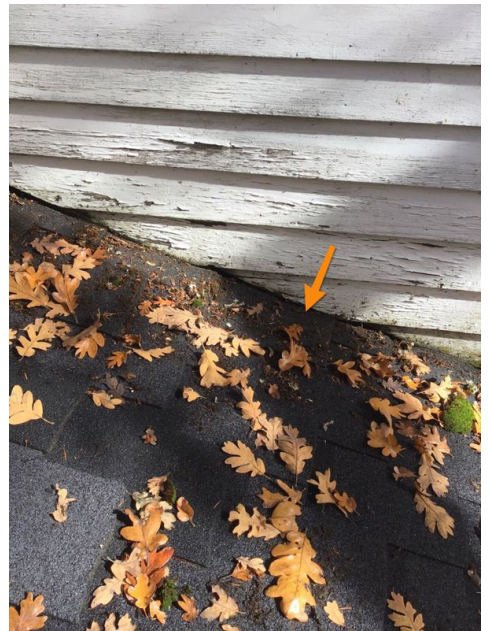
South bath dormer roof contact

2.3.1 Flashing

INCORRECT

Contact a qualified roofing professional.
