# **FEASIBILITY STUDY**

# 1.0 - EXECUTIVE SUMMARY

The Walker House is a historic dwelling set amid an idyllic, wooded site in White Salmon, WA. This study examines the feasibility of modifying the building to become a central gathering place for the community. With proposed programs that include rental space for meetings, artist residencies, retail, and seasonal uses such as an ice cream parlor and wedding venue, the reimagined Walker House would result in a change of occupancy, which, in turn, would require several coderelated upgrades.

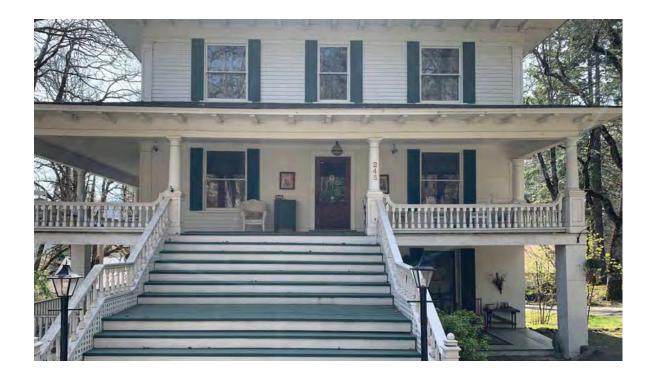
The guard railings along the north entry steps, main floor porch, and lower level porch are in need of updates to meet current height requirement of 42 inches above finished floor. The spacing between rails exceeds the 4-inch maximum allowed. Furthermore, the stair railings are not secured fully and move with ease. A handrail on the north stair needs to be added to one side; at the south stair, guardrails and a handrail need to be added on one side. The interior stairway is in need of code-compliant handrails and updates to guardrails to meet current height and spacing requirements.

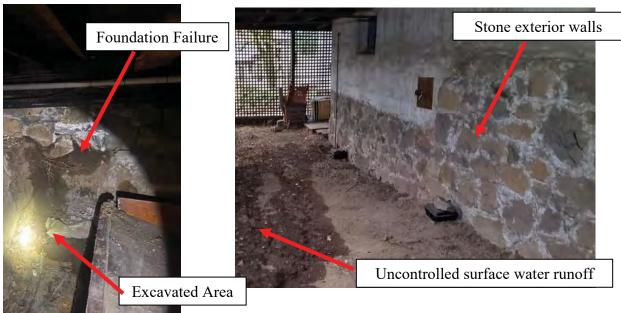
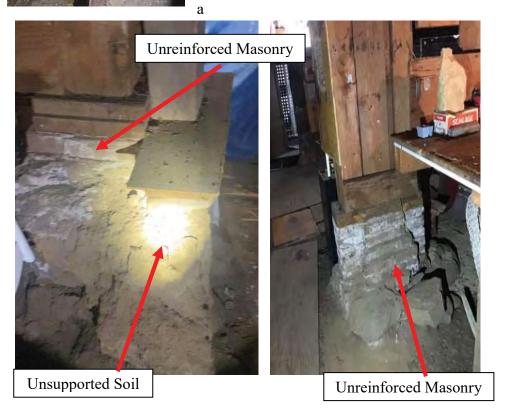
The foundation is a fairly intact rock and mortar foundation. At the northwest corner of the house there is a small area of foundation failure. The failure consisted of a number of rocks being out of place and the mortar had crumbled. There is loose soil in the area and some evidence of moisture coming through the foundation. Failure is small and not a likely cause for concern. Highly recommend providing better drainage around this area of the foundation to prevent any further damage due to water.

The isolated footings supporting posts below the house looked to be insufficient. With the exception of a few newer 4x4 posts bearing on concrete footings, all other post footings were comprised of stacked rocks or bricks with areas of unsupported soil below the footings and foundation wall locations. These footings should be better supported by adding concrete retainment around the footings to confine the soils from failing.

It should be noted that no positive connections were observed under the house. All post to beam connections were found to be nailed. The lack of positive connections paired with the rock and mortar foundation are indications that this house does not meet modern seismic code. These connections should be upgraded to positive connections.

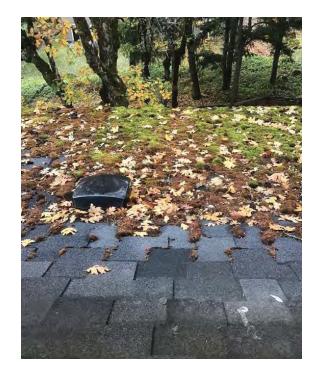
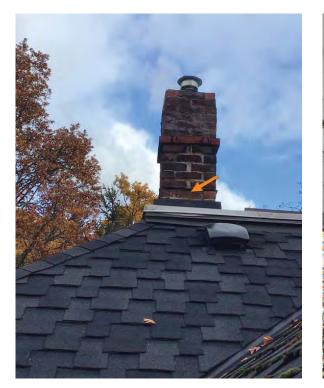
### **IMAGES**

Chimney is deteriorating - recommend further review and repair. Joints in the masonry have deteriorated and should be re-pointed.

Indications of worn out areas, delayed maintenance, or aging. Ongoing caulking and painting is needed to areas of the structure presently and eventually in the future a complete repaint before large areas start to show signs of peeling and aging paint. Soiled areas at west side eave require minor cleaning.

Moss or lichen was seen growing on the roof recommend cleaning it off. Flashing at south dormer in need of review and repaint, siding is covering and in contact with roofing material.

Framing review and updates needed, ledger board fasteners absent, attachments and supports limited. Some damaged wood seen at base of stair and recommend repair. Wood decay observed at the base of stair, further evaluation of the deck recommended. Framing members for the deck are either in or very close to the soil, the material does not appear to be pressure treated or naturally decay resistant.

There was some minor cracking in the hallway ceilings and the lower bathroom ceiling. Given the age of the home, this structure appears to have had limited visible updates and repairs due to shifting or movement within the structure.

Some repaired areas noted in the bathrooms - future floor covering updates, caulking needed around tubs, toilets, and sinks. Some updates to existing fixtures needed. Bathroom fan in need of updates and confirm exhaust route to exterior.
