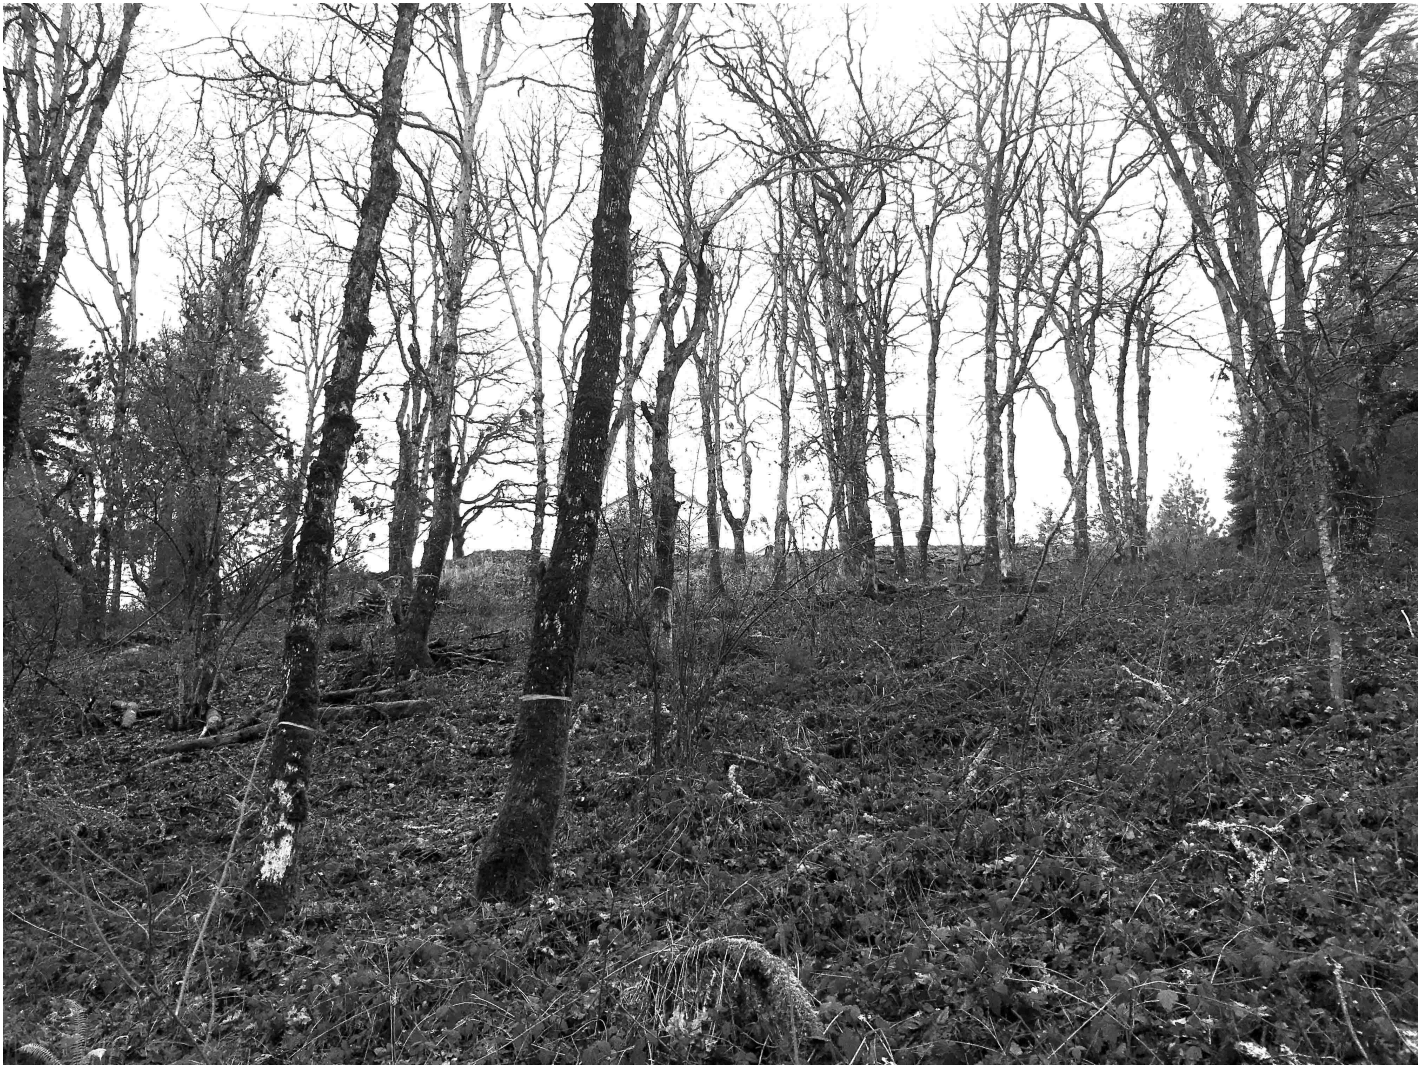
IMAGE 40 - TAKEN LOOKING UPHILL FROM LOWER PORTION OF PROPERTY. NOTE THAT TREES ARE ALL ROUGHLY SIMILAR IN FORM, DESPITE VARYING TRUNK DIAMETERS, DUE TO COMPETITION FOR LIGHT.

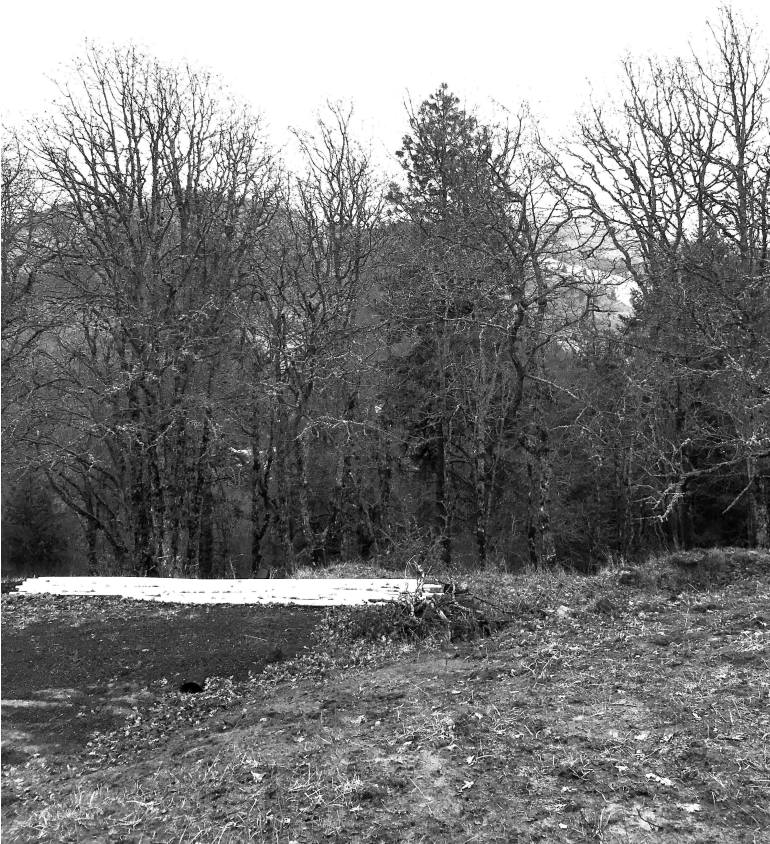
IMAGE 41 - TAKEN LOOKING DOWNHILL FROM UPPER PORTION OF PROPERTY. NOTE THAT CONSTRUCTION OF GRAVEL PARKING PAD SEEN IN IMAGE OCCURED DURING PREVIOUS OWNERSHIP.
