Tree Assessment

May 2022

In May 2022, Treecology Consulting Group (TCG) conducted a risk assessment, and site evaluation for one street tree at 218 Jewett Blvd. in White Salmon, WA. The tree was assessed on May 20, 2022 by Ruth Williams, International Society of Arboriculture (ISA) Board Certified Master Arborist #WE-7317-BM, ISA Tree Risk Assessment Qualified. The results of this assessment are documented in this report. The goal of this assessment is to provide strategies to manage the tree and site that may impact people and property, and to guide long-term tree care decisions. Considerations include tree health, safety, and site history.

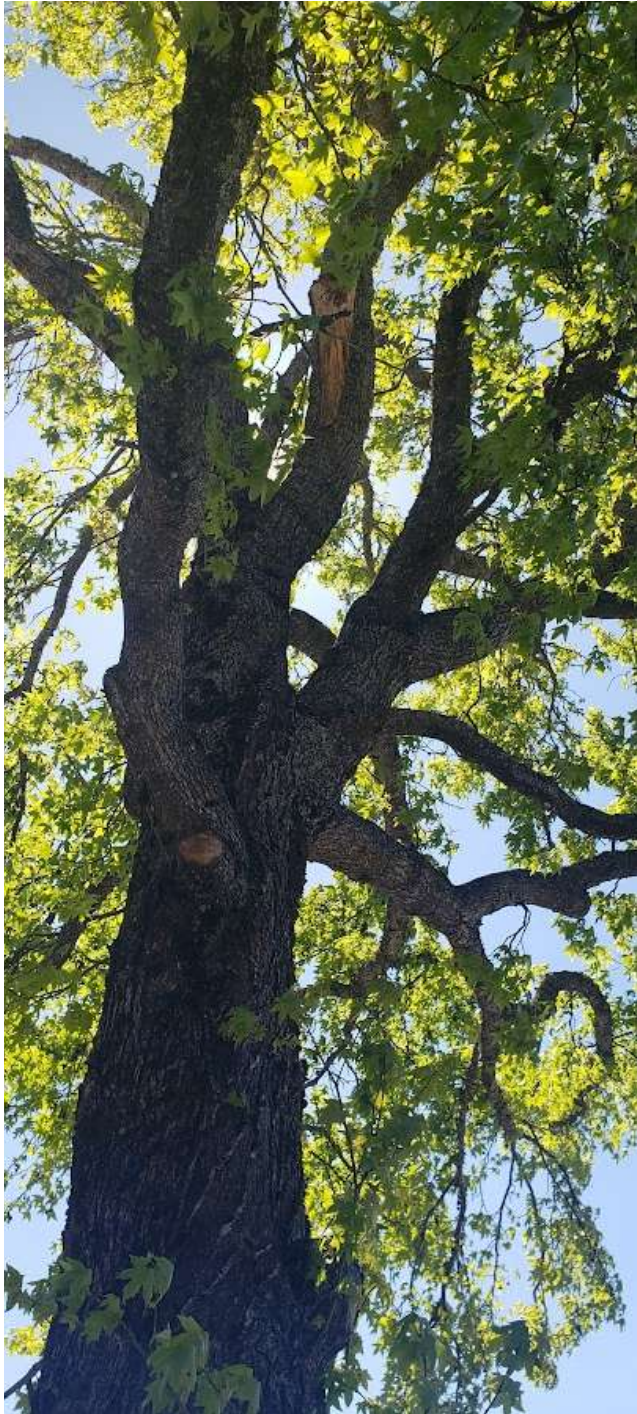
North side limb failure

- Pruning: routine end-weight reduction/clearance pruning (cuts largely below 3” diameter in the upper outer ⅓ of the canopy) and aerial inspection for hidden defects every 3-5 years will decrease the likelihood of future limb failure, resulting in a residual risk rating of low. This should be conducted within the next 1-2 years. The tree must be pruned up to 8 feet above sidewalks for clearance and 14 feet above any roadways. The tree should be monitored, and an arborist consulted if changes are noticed in vigor or lean, and after significant storms. The adjacent retaining wall and upper sidewalk should also be monitored for cracking.

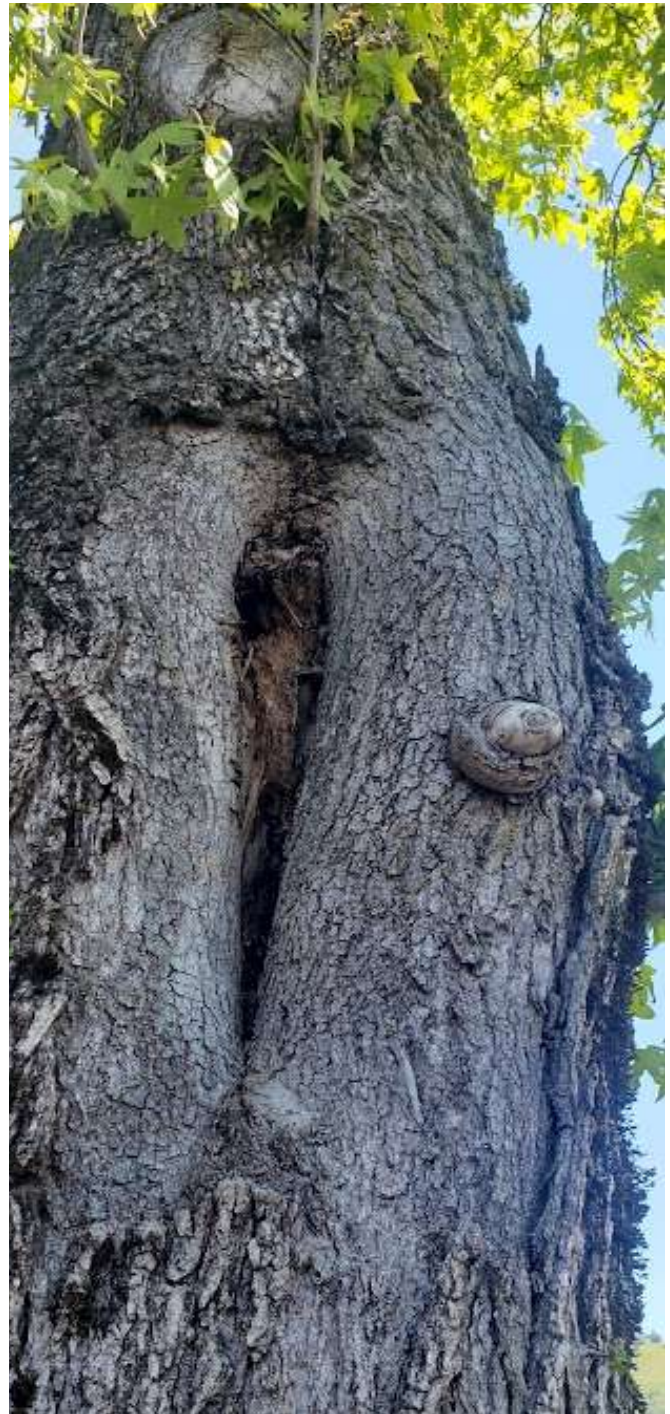
This tree is an open-grown tree with two prior limb failures. One was on the south side (photo, right), toward the street several years ago, and the wound has mostly sealed over. The outer 2-3" of wood beneath the wound is spongy and delayed. Minor epicormic sprouts are present near this wound. A second wound is visible on the north side, higher in the canopy. It looks recent, within the past 3 years. These wounds are consistent with the species that tends to have moderately brittle branches, and tends to fail where included bark is present.

South side limb failure (close up) shows decay/splintered wood indicating prior failure, not pruning wound. Smaller pruning wound above is sealed.

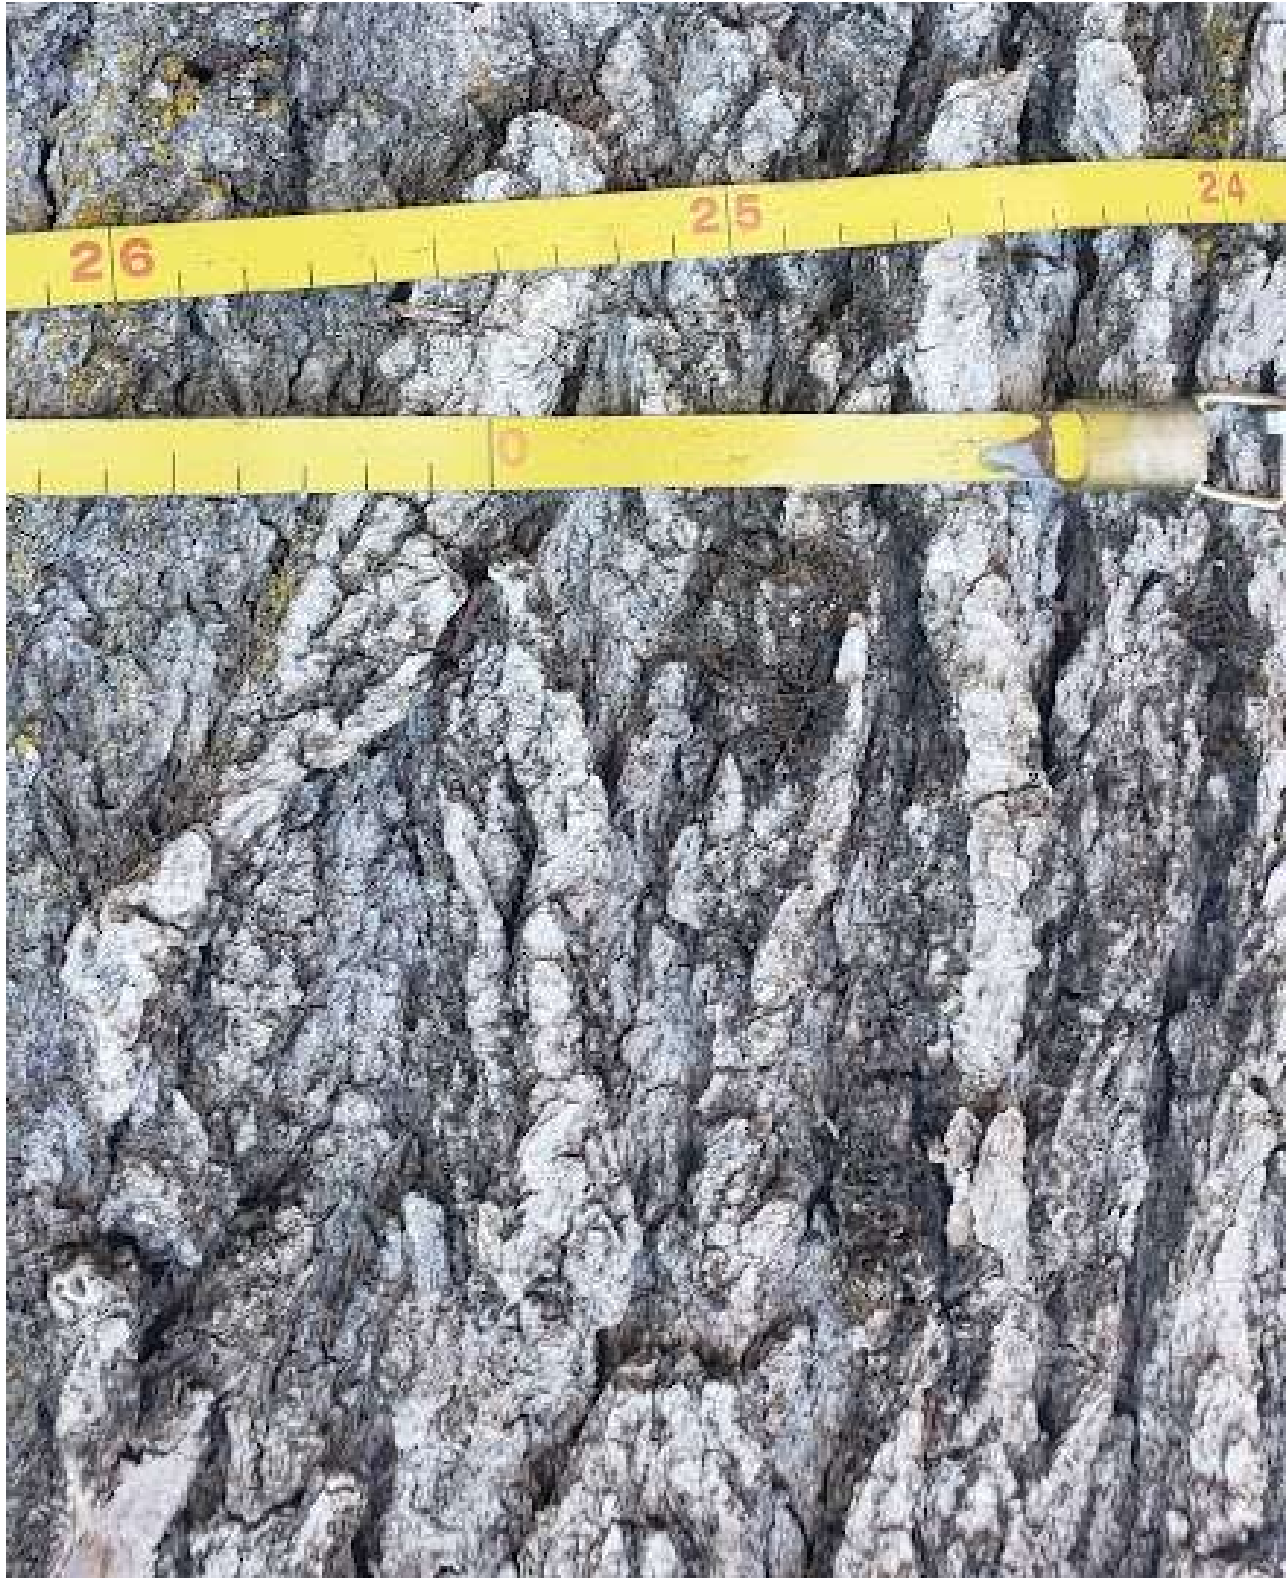
Photo 4. DBH tape on trunk showing over 25" DBH May 20, 2022
