ENVIRONMENTAL CHECKLIST GUIDANCE

Cherry Hills Estate, White Salmon (WA)

AMENDED: NOVEMBER 28, 2023, BY HRK ENGINEERING & FIELD SERVICES

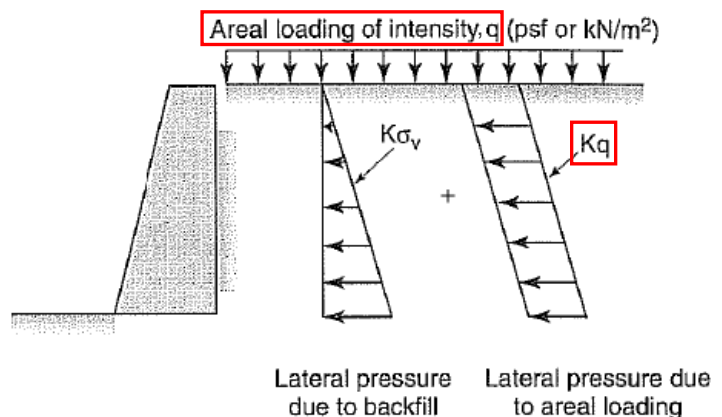
AREAL LOAD:

Where H = wall height (feet)
