**ORIGINAL HOME
INSPECTION
SUMMARY**

245 W Jewett Blvd, White Salmon WA
98672
Marla Keethler
October 29, 2021

Steve Gibson
Certified Real Estate Inspector Since 1998
InterNACHI 12041805 | Washington #
379 Oregon # 76 - Licensed Construction
Contractor # 129290
Buyers & Sellers Home Inspection Service

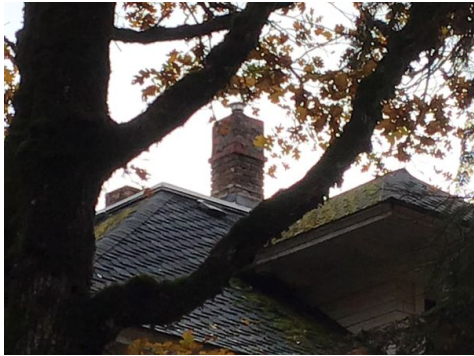
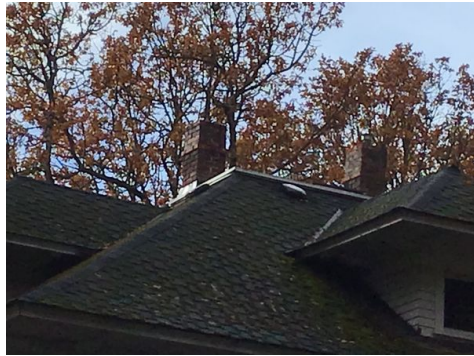
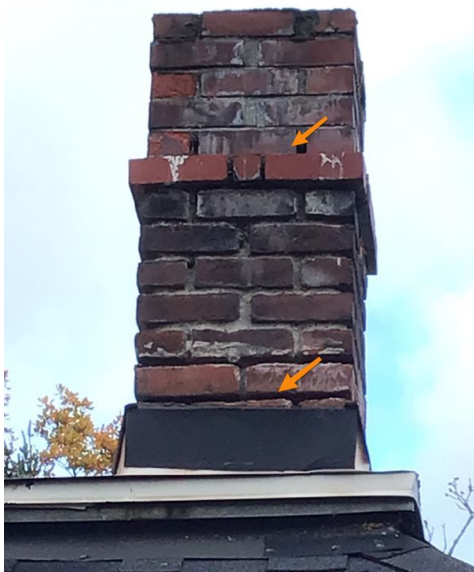
CHIMNEYS DETERIORATED

Chimneys is deteriorating recommend further review and repair. See pictures below.

CHIMNEY REPOINT NEEDED

Joints in the masonry have deteriorated and should be repointed. (Repointing is the restoration of the mortar joints in the masonry). Suggest a masonry professional review the homes masonry systems for a final determination of attention needed.

Contact a qualified masonry professional.

Contact a qualified chimney contractor.

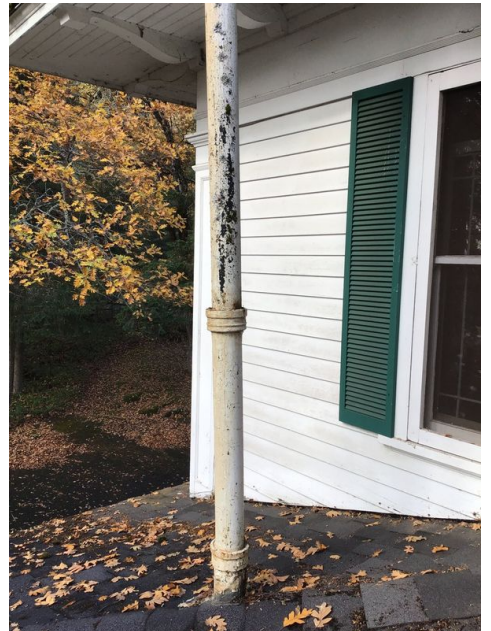
2.1.4 Chimneys, Vents & Roof Penetrations
PAINT ATTENTION TO VENT PIPE

Recommendation
Contact a qualified professional.

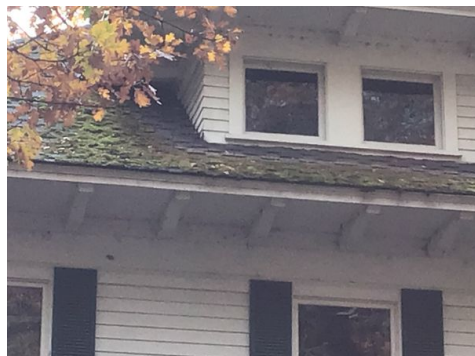
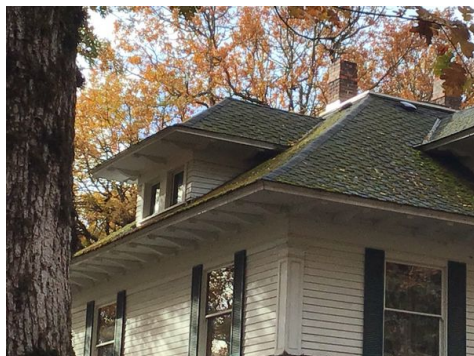
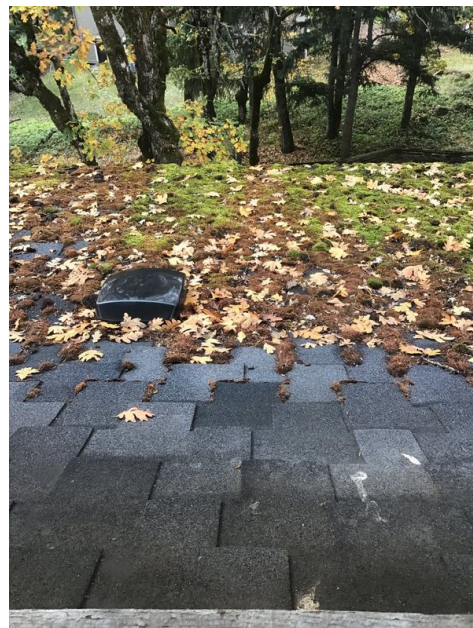
2.2.1 Roof Covering **MOSS | LICHEN GROWTH**

Moss or lichen was seen growing on the roof recommend cleaning it off. Hiring a professional is the safest method.

Recommendation
Contact a qualified professional.

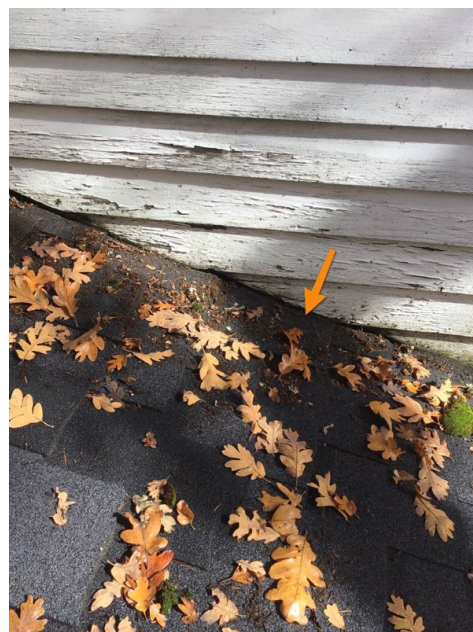
South bath dormer roof contact

2.3.1 Flashing **INCORRECT**

Flashing is incorrect, recommend further review and repair by a licensed roofing contractor. The vertical lower area of the flashing "should" be exposed. The siding is covering and in contact with the roofing material.

Recommendation
Contact a qualified roofing professional.

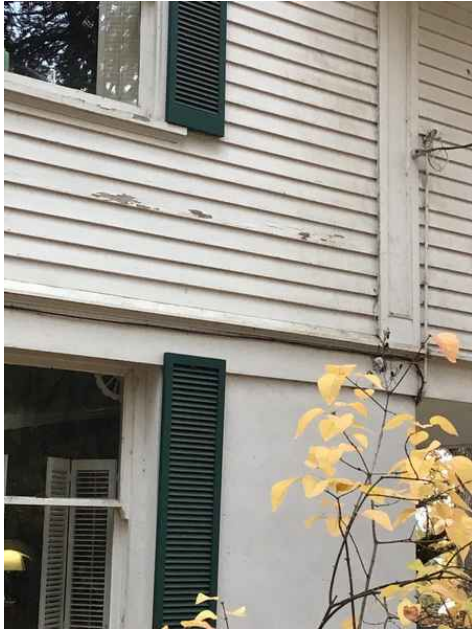
West Side SW bedroom wall

AGED PAINT/ STAIN

Recommend re-painting or re-sealing areas of the exterior of the home. Paint prep and caulking is required first.

Contact a qualified professional.

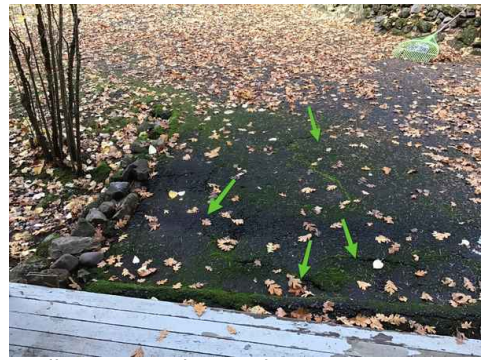
Walkway near lower door entry- NW corner

SOME CRACKING AT WALKWAY/SIDEWALK

NORTHWEST NEAR LOWER ENTRY DOOR - BUMPS NOTED IN THE ASPHALT.

I observed cracking at the walkway. This condition could be a trip hazard.

Correction and further evaluation is recommended.

Contact a handyman or DIY project

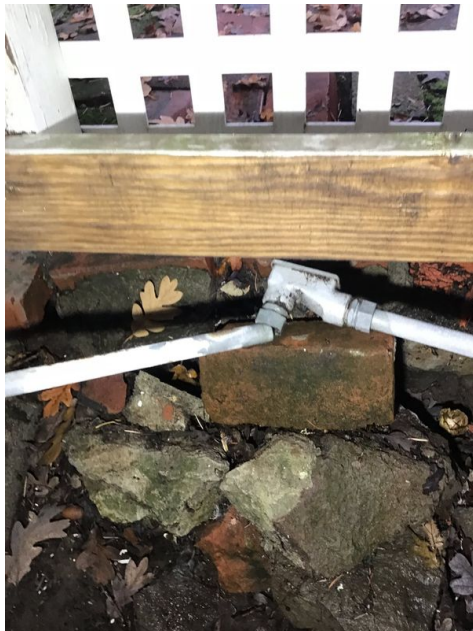
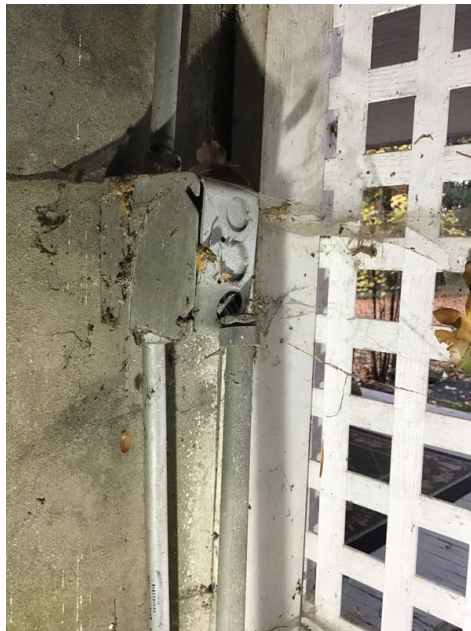
3.7.1 Electrical & GFCI's
ELECTRICAL DEFECT

I observed indications of an electrical defect at the exterior. Damaged wiring conduit in areas - and not secured.

Contact a qualified electrical contractor.

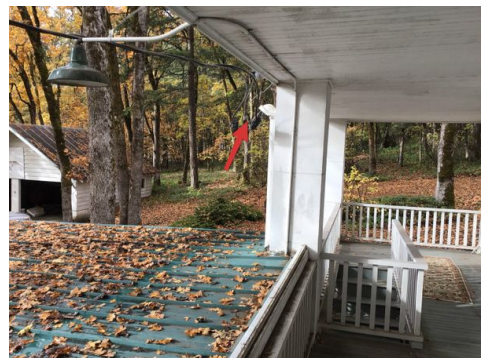
South

3.7.2 Electrical & GFCI's
CLEARANCE SERVICE WIRE

Overhead feed to the within reach of the south porch- this is a possible safety hazard recommend review by a licensed electrician.

Contact a qualified electrical contractor.

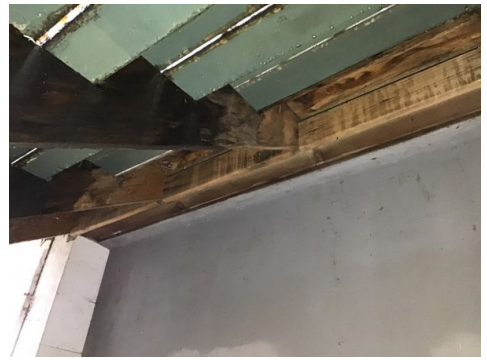
I observed indications of a defect at the ledger board of the visible framing of the period porches.

The ledger boards are not properly attached to the building with current standards. This can cause the porches to pull away from the building and possibly collapse. No visible metal bracket fastening devices.

Correction and further evaluation is recommended.

Contact a qualified deck contractor.

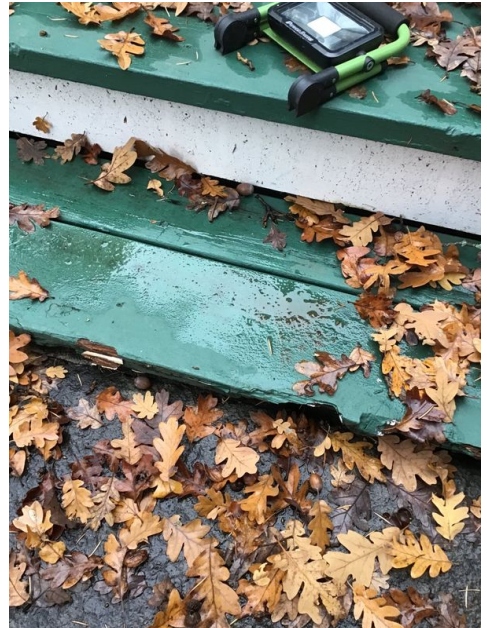
DAMAGED WOOD

Some damaged wood seen recommend repair by a qualified professional.

Contact a qualified deck contractor.

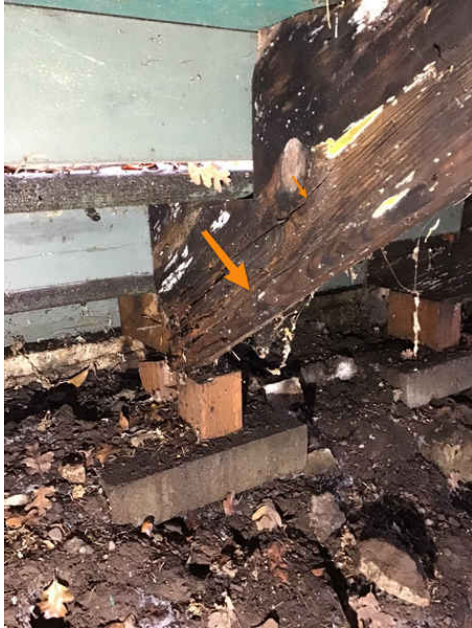
At the base of the N steps

DECK - WOOD DECAY / ROT

I observed wood decay / rot at the deck. This condition is a structural defect. More decay / rot may be found at other areas.

Correction and further evaluation of the deck is recommended.

Contact a qualified deck contractor.

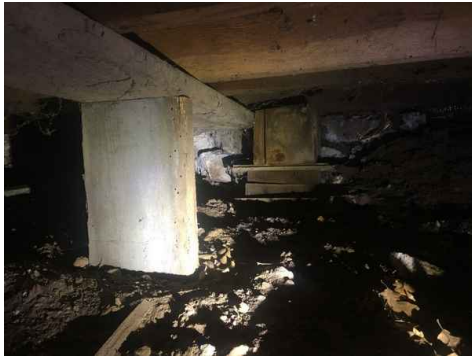
DECK - GROUND CLEARANCE

Framing members for the deck are either in or very close to the soil, the material does not appear to be pressure treated or naturally decay resistant- recommend repair. If not corrected- overtime the wooden members will decay.

1. Areas below the wood steps at the N side- Lower level steps. See prior pics.
2. Two wooden supports were noted in contact with soils under the lower height NW porch area near the lower level N side door. Past repair were noted. (Some newer wood with metal brackets)
3. Areas adjacent to this area of the wood porch are in contact with rock and soils it appears and will require ongoing attention.

Contact a qualified professional.

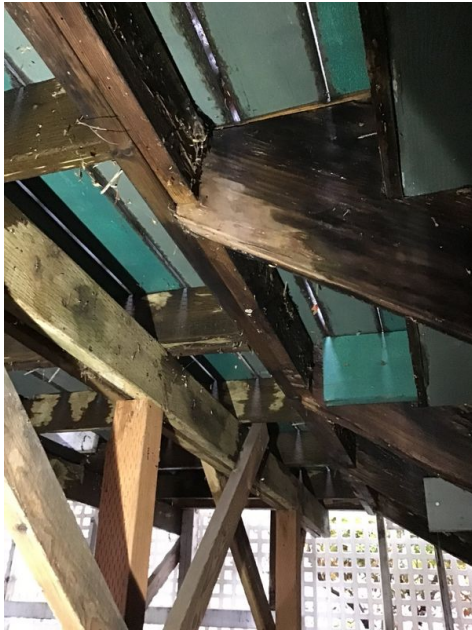
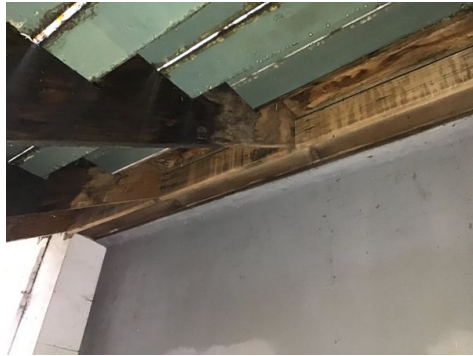
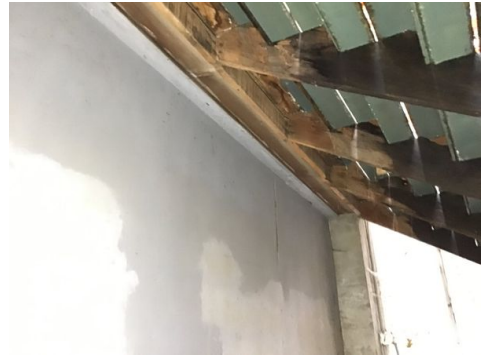
DECK-HARDWARE RECOMMENDED

Recommend installing hardware on the post and beam connections for the porch/stair framing. Consider updates to newer seismic standards. A licensed decking contractor can offer a final determination of attention needed.

Contact a qualified deck contractor.

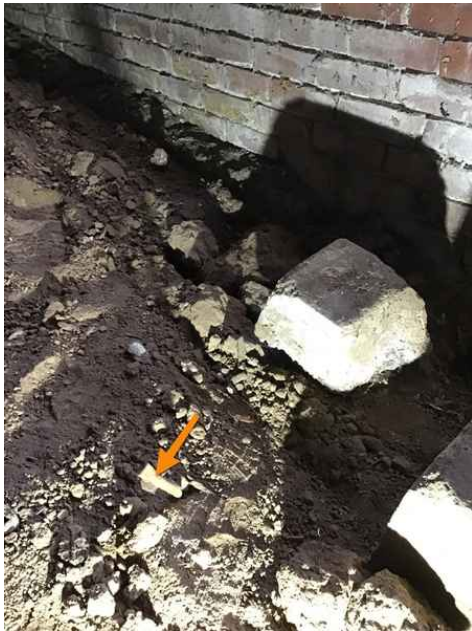
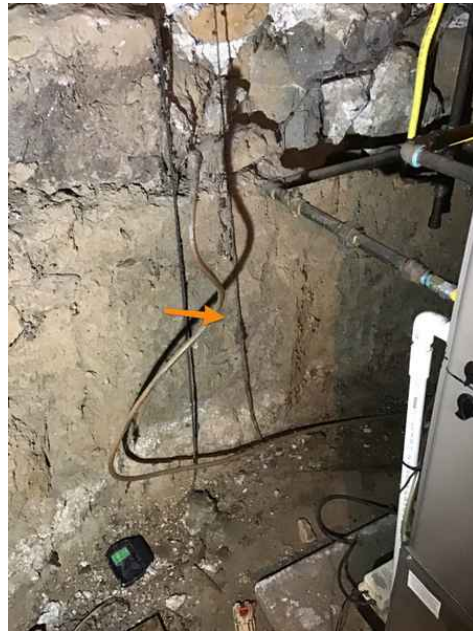
3.12.1 Copper pipe visible - east side

Contact a qualified professional.

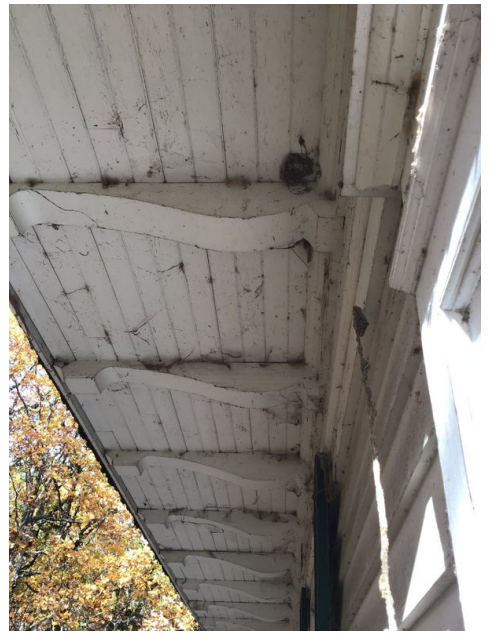
3.13.1 Minor cleaning needed - west side

SOILED AREAS

Contact a qualified professional.

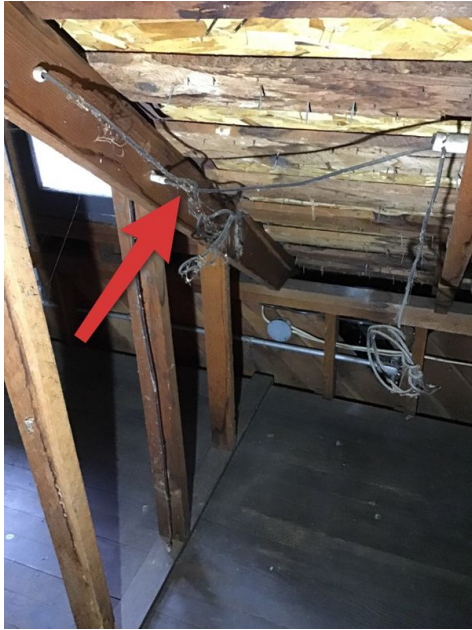
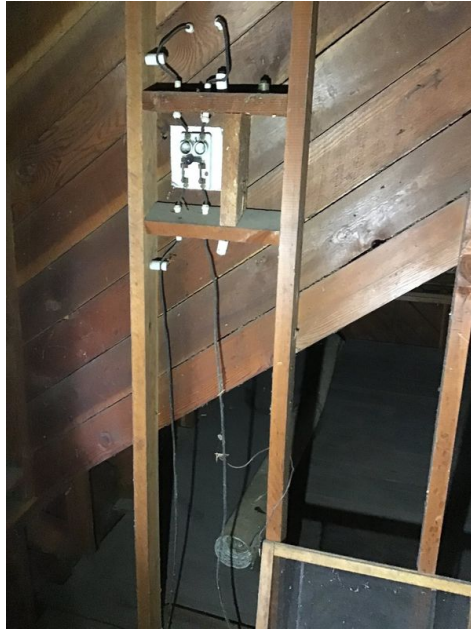
PAST FIRE INDICATIONS NOTED

Confer with the seller and or the local fire official for information about the past history of a fire(s) in the home. The amount of charred or replaced newer wood appears limited.

Contact a qualified professional.

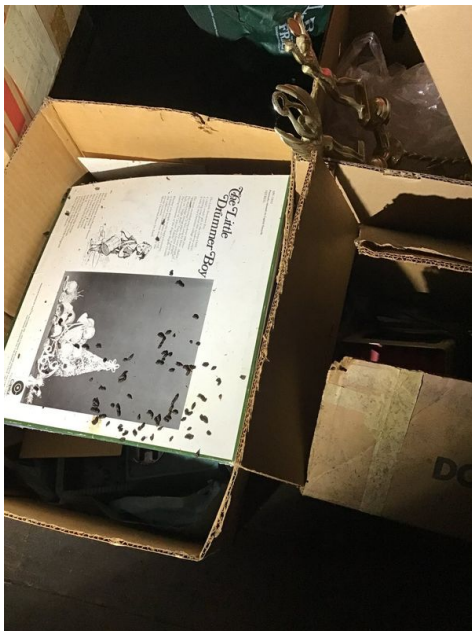
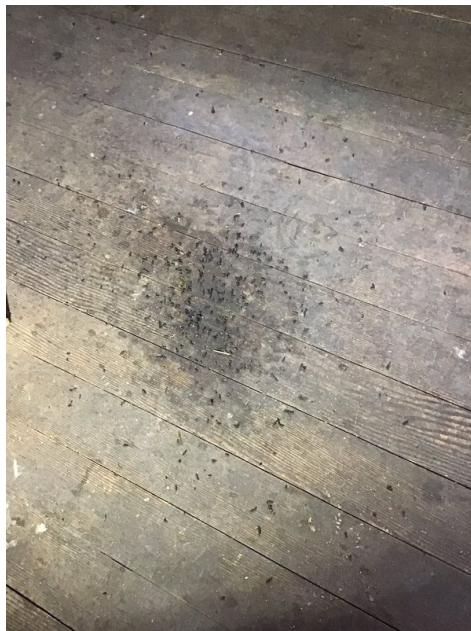
POSSIBLE ACTIVE PEST ENTRY

Noted in a few areas within the large attic. Trapping or sealing of gaps is suggested around windows and or chimney systems. A pest professional can offer more information.

Contact a qualified professional.

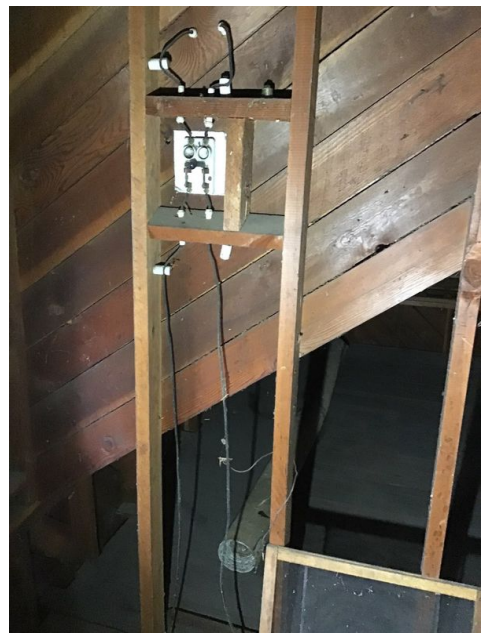
I observed exposed live AGED FUSE SYSTEM and aged electrical wires that appears still in use. Updates are warranted. Suggest a licensed electrician review the structures electrical systems for a final determination of attention needed for occupant safety.

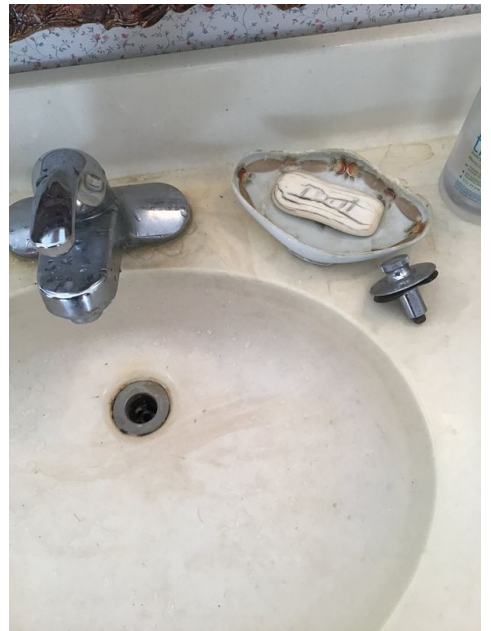
11.2.2 Sinks, Tubs & Showers
SINK STOPPER NOT IN PLACE

Recommendation
Contact a qualified professional.

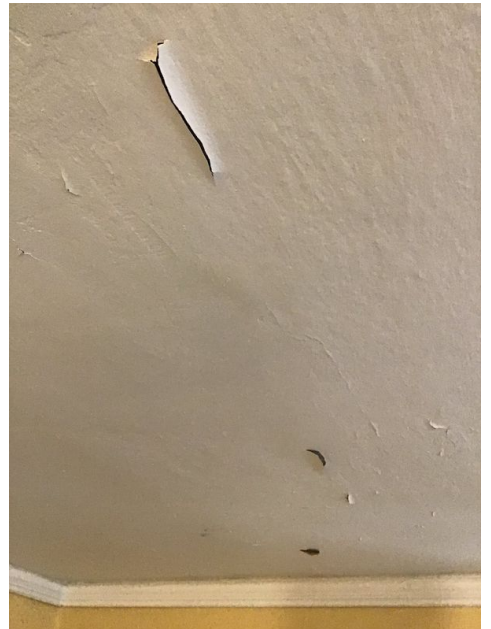
11.2.3 Sinks, Tubs & Showers
PEELING CEILING PAINT LOWEST BATH-

No bath fan noted

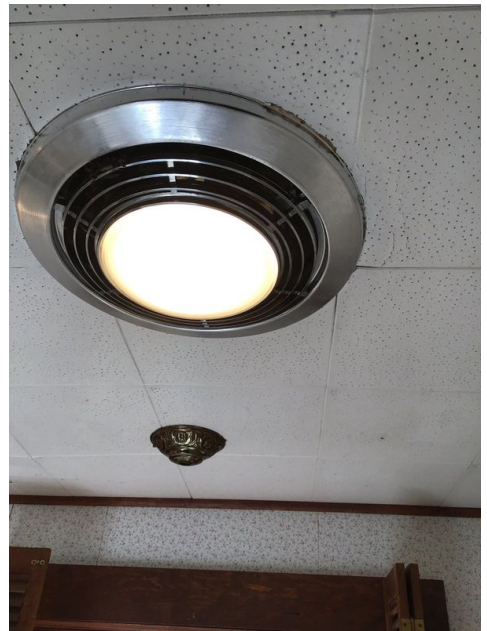
HEAT LAMP DEFECT

Aged unit updating is suggested

Contact a qualified electrical contractor.

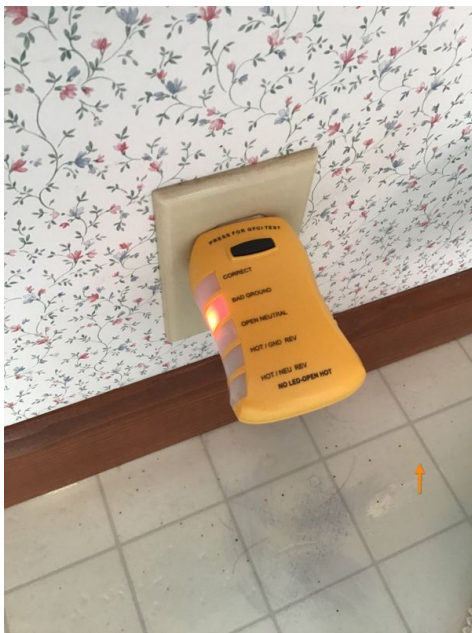
Non grounded outlet near the tub below the window-

Contact a qualified electrical contractor.

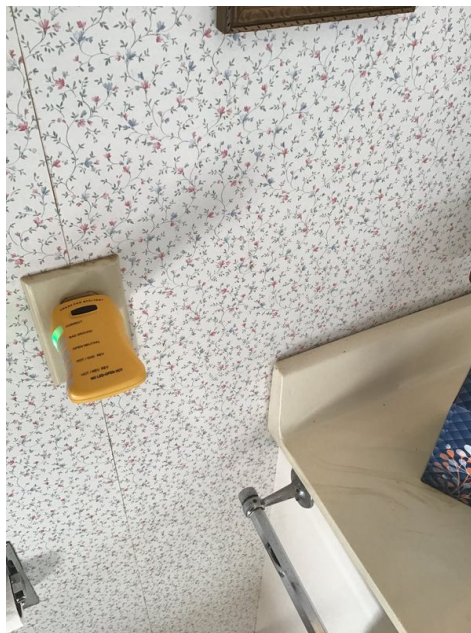
GFCI needed

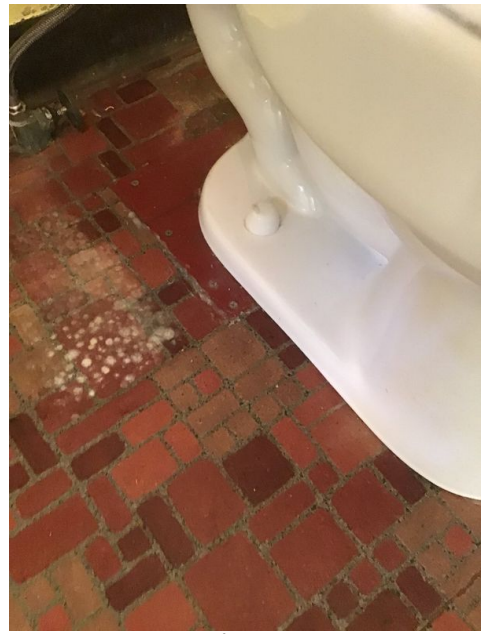
I observed damage at the bathroom floor. All three bath areas have aged flooring with repairs. Ongoing caulking and touch up will likely be needed.

Past repairs noted

Contact a qualified handyman.

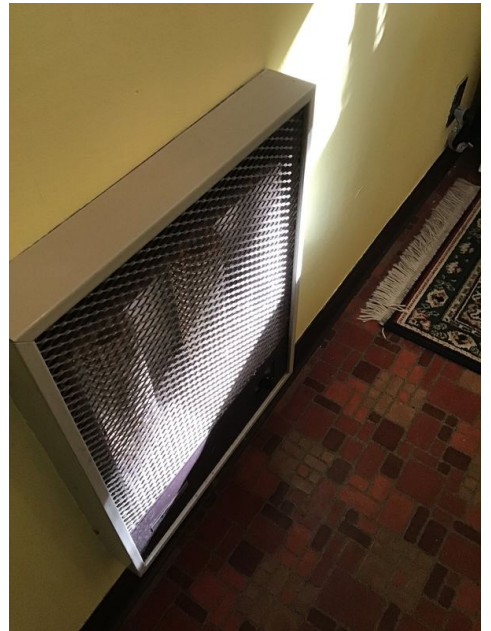
DATED WALL HEATER FOR UPDATING

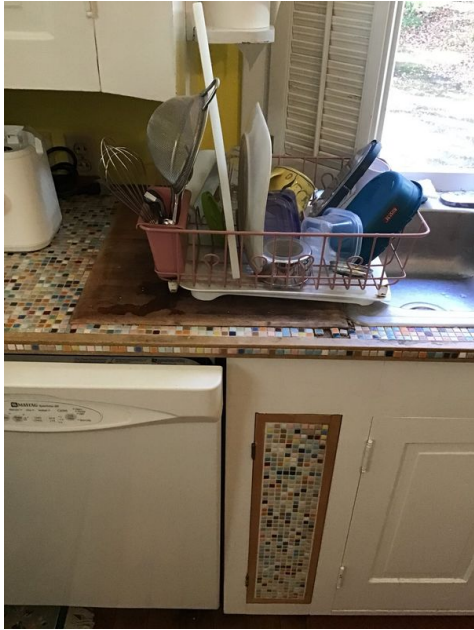
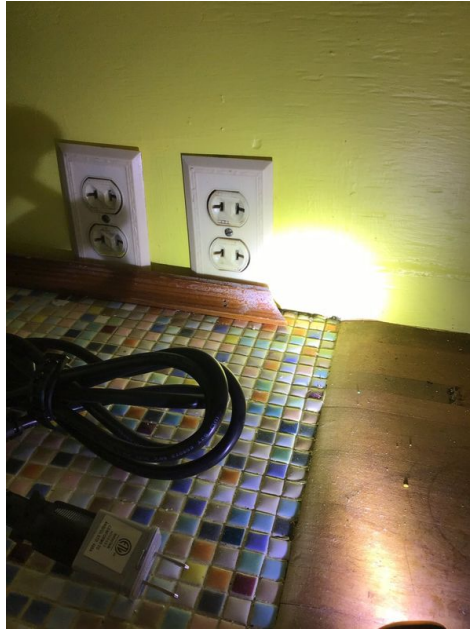
I observed indications of missing GFCI protection in the kitchen. All kitchen counter receptacles are required to be GFCI protected.

Contact a qualified electrical contractor.

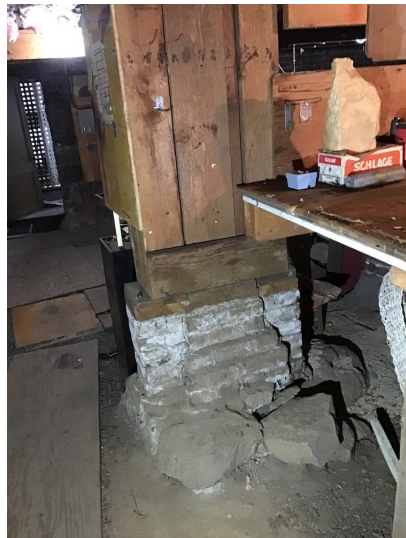
It appears years ago soil was removed in areas of the sub area-added supports were noted in some locations. As pictured below soils have no support in some locations near the homes rock and mortar foundation areas. Updates are warranted with concrete to fully support the load bearing soils. Other added posts appear to have limited fixed attachment methods at the post and beam connections. An added post near the main water heater appears to not be load bearing and requires attention. Other older post supports have been added overtime that now may require updating. Metal fastening devices and lag screws intended for better attachment methods are now available.

A foundation specialty engineer and or an experienced and proven contractor should review the entire basement area for a final determination of attention needed.

Recommendation
Contact a qualified professional engineer

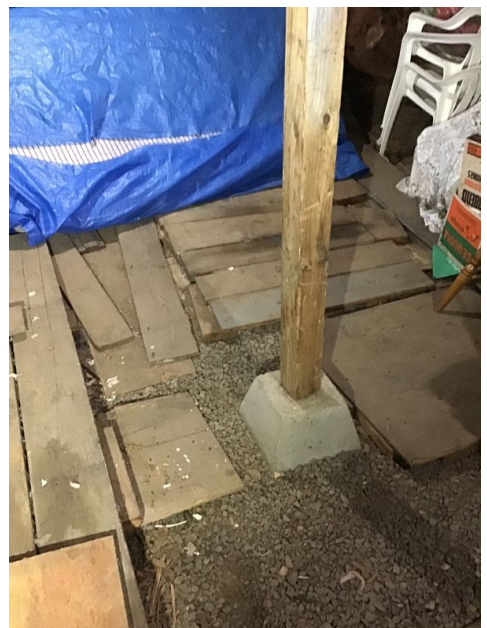
All exposed soils should be fully covered with a black 6 mil covering overlapped and sealed to the masonry if possible. This will help to control water vapor rising up with the home and dust within the structure. All wood debris and stored wood items should not in contact with soils to aid in preventing pest infestation. Removal is suggested or storing up away from the soil level.

Recommendation
Contact a qualified professional.

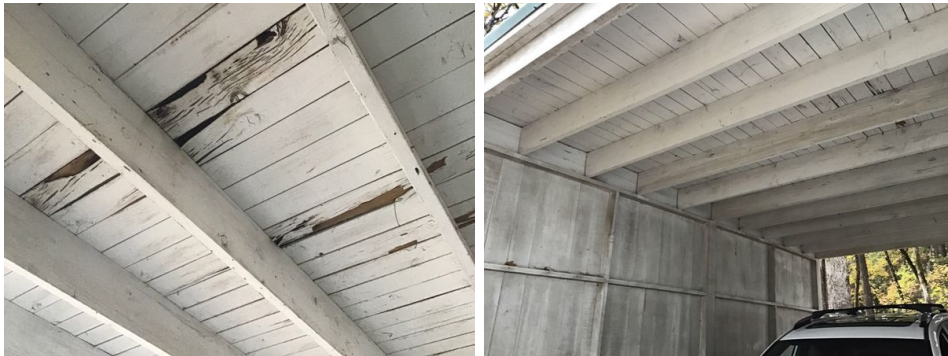
As noted when leaf debris gather on the roof covering water can back up and find methods to seep through the metal covering at seams and screw attachment locations. Some discoloring of wood sheathing was noted from below which indicate moisture intrusion.

Contact a qualified professional.

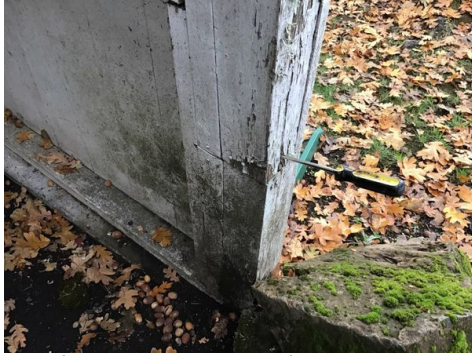
I observed structural defects at the carport. This was noted as secured some to the main structure in only a few locations with metal anchors - but it appears that updates and repairs are warranted. A licensed contractor and or structural engineer is suggested for a final determination of attention needed.

Southwest corner Wood Decay

Contact a qualified general contractor.

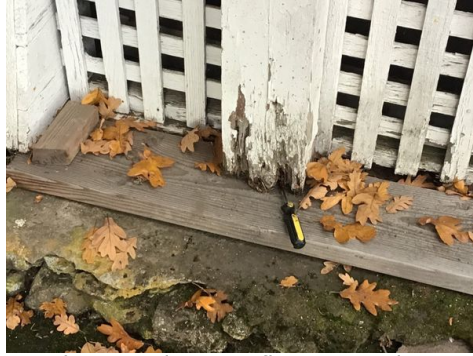
Northeast Side- Post floating and damaged

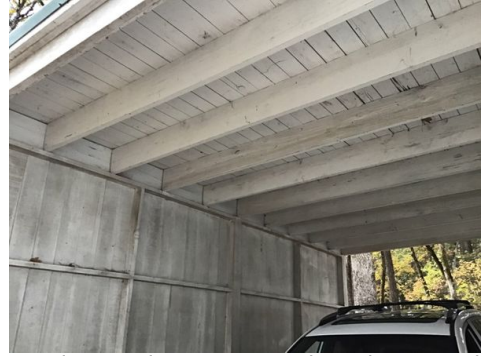
No diagonal support work and or metal supports

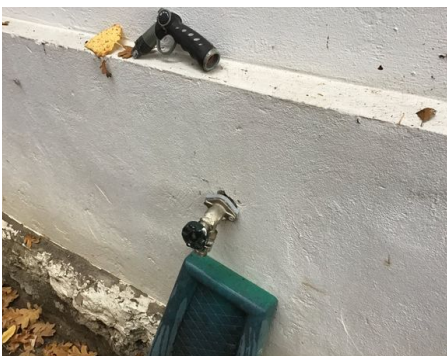
Most homes have two hose bibs outside the home. One noted on each side. The W side is loose in the wall. Minor attention is suggested to secure it with screws as intended.

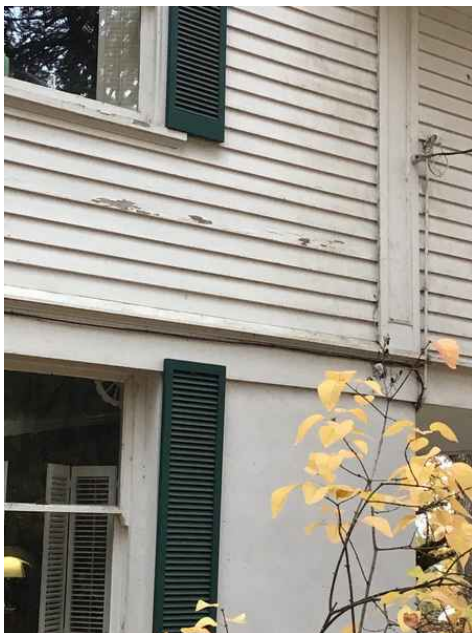
West Side SW bedroom wall

AGED PAINT/ STAIN

Recommend re-painting or re-sealing areas of the exterior of the home. Paint prep and caulking is required first.

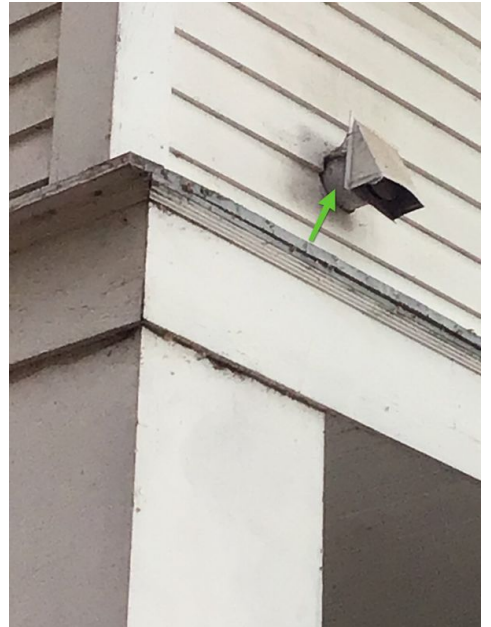
There was some holes seen in the siding and trim where pests could get into the home it would be recommended to seal these openings.

Contact a qualified professional.

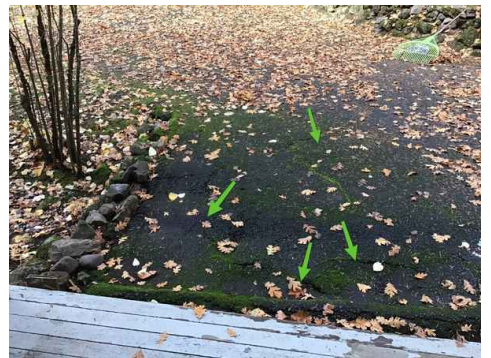
Walkway near lower door entry- NW corner

SOME CRACKING AT WALKWAY/SIDEWALK

NORTHWEST NEAR LOWER ENTRY DOOR - BUMPS NOTED IN THE ASPHALT.

I observed cracking at the walkway. This condition could be a trip hazard.

Correction and further evaluation is recommended.

Contact a handyman or DIY project

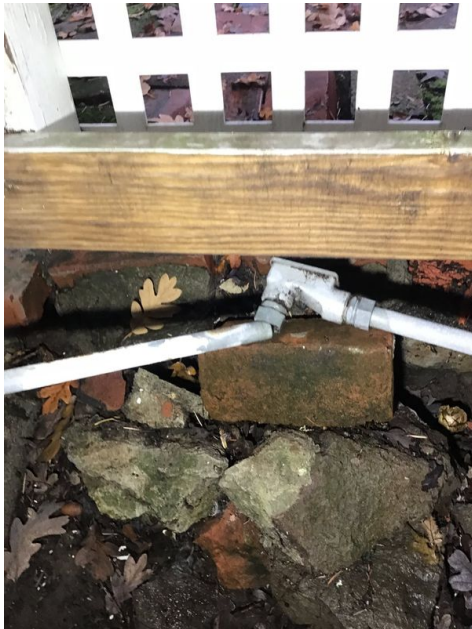
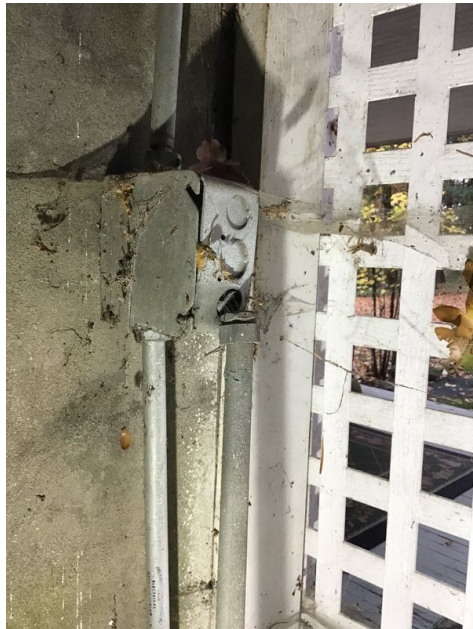
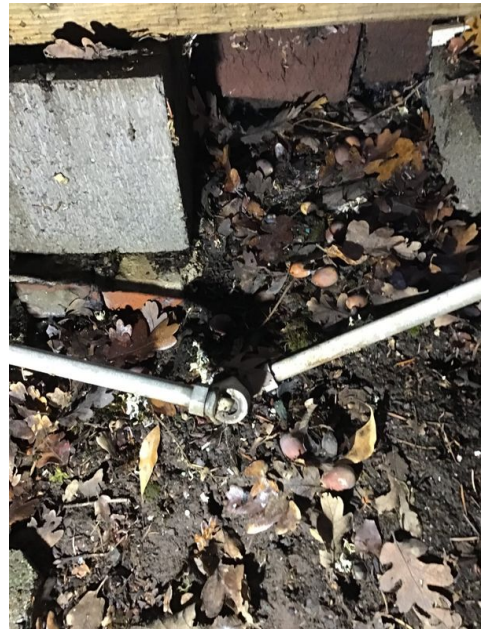
ELECTRICAL DEFECT

I observed indications of an electrical defect at the exterior. Damaged wiring conduit in areas - and not secured.

Contact a qualified electrical contractor.

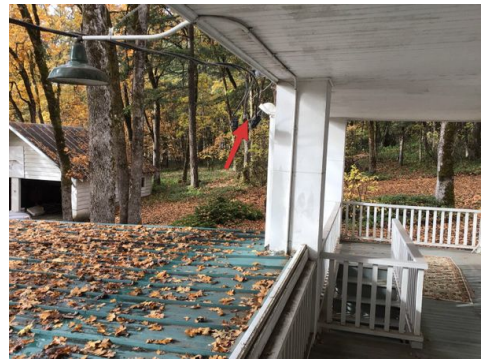
South

CLEARANCE SERVICE WIRE

Overhead feed to the within reach of the south porch- this is a possible safety hazard recommend review by a licensed electrician.

Contact a qualified electrical contractor.

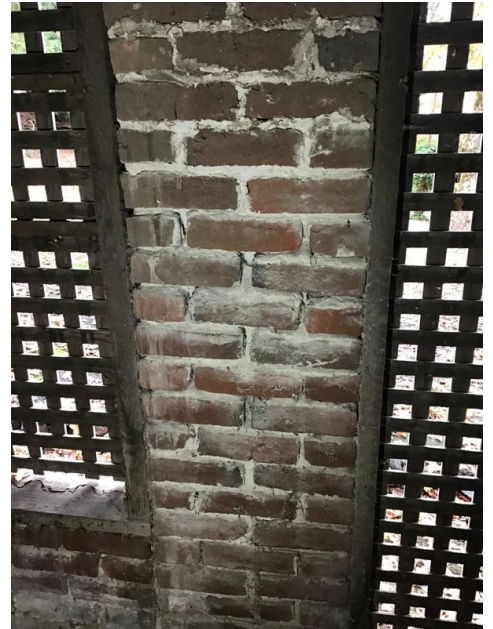
East

BRICK WORK FOR TUCK POINT REPAIRS

Contact a qualified professional.

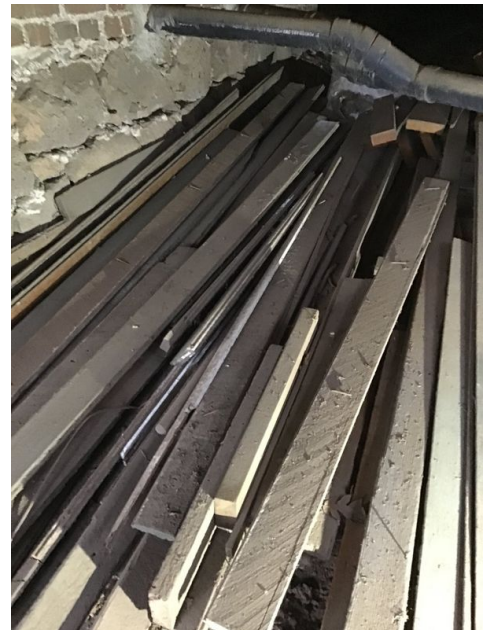
North

Noted under the N porch area.

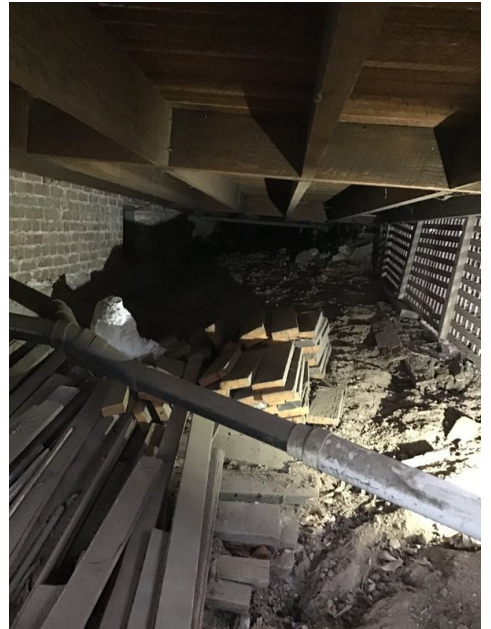
LOW ACCESS NOT FULLY VISIBLE

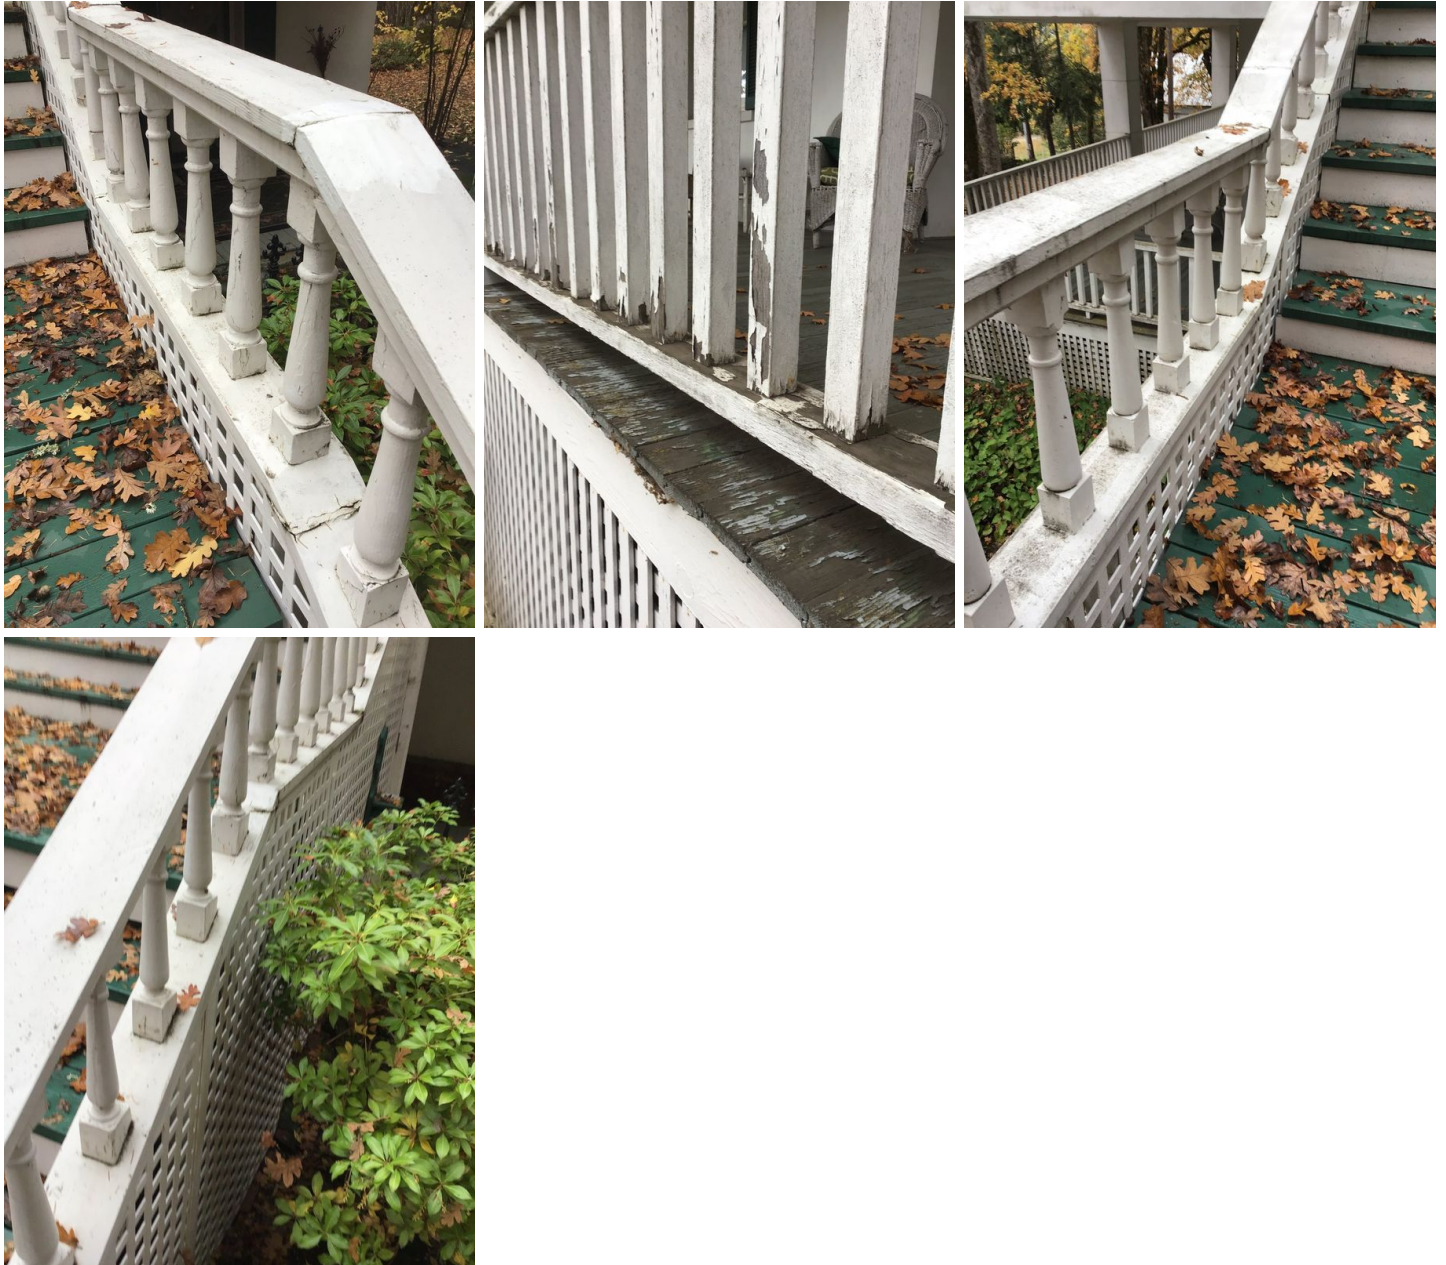
DETERIORATED CONDITION AT FRONT STEP SIDE RAILINGS.

I observed indications of deteriorated and aged conditions at the deck components. The side railing are NOT secured fully to the main stair system it appears. They were noted to move with ease when pushed upon. The smaller rear stair system has limited side hand railings and pickets and supports.

Contact a qualified deck contractor.

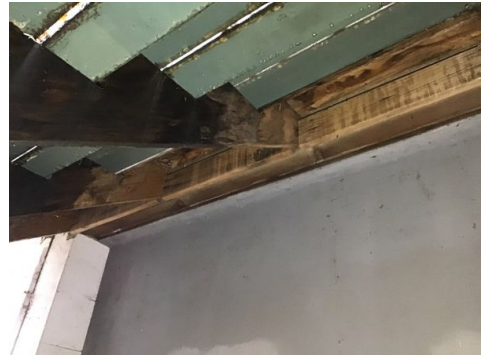
LEDGER BOARD FASTNERS ABSENT

I observed indications of a defect at the ledger board of the visible framing of the period porches.

The ledger boards are not properly attached to the building with current standards. This can cause the porches to pull away from the building and possibly collapse. No visible metal bracket fastening devices.

Correction and further evaluation is recommended.

Contact a qualified deck contractor.

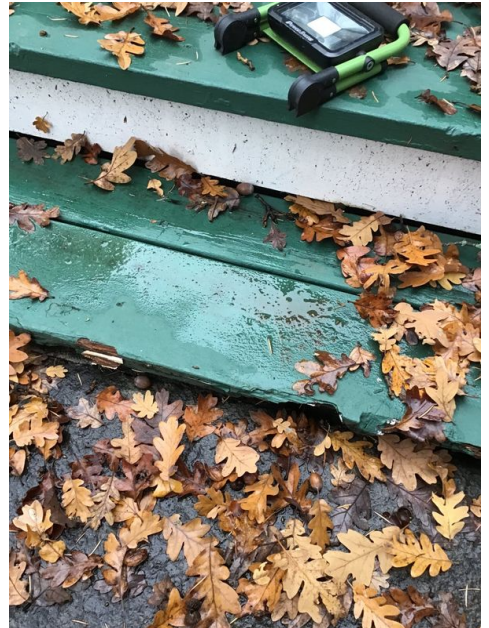
DAMAGED WOOD

Some damaged wood seen recommend repair by a qualified professional.

Contact a qualified deck contractor.

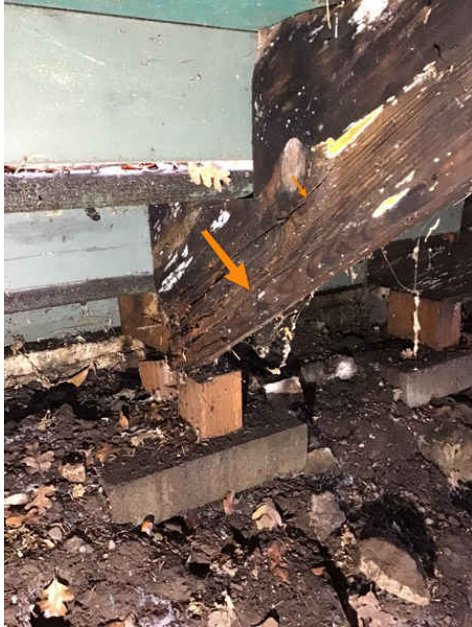
At the base of the N steps

DECK - WOOD DECAY / ROT

I observed wood decay / rot at the deck. This condition is a structural defect. More decay / rot may be found at other areas.

Correction and further evaluation of the deck is recommended.

Contact a qualified deck contractor.

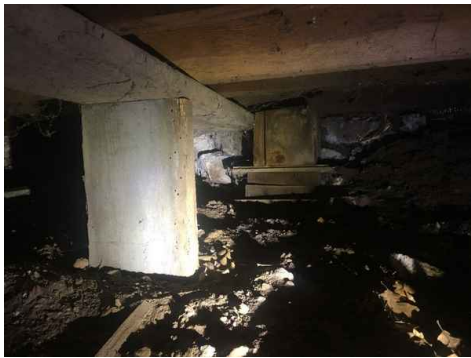
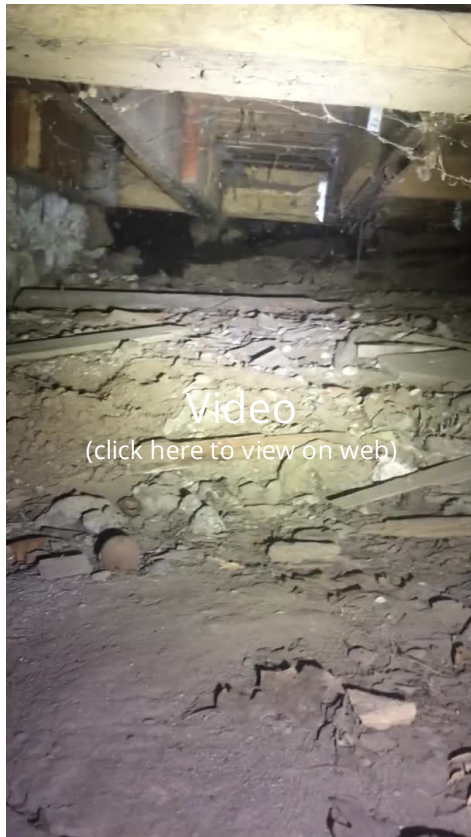
Framing members for the deck are either in or very close to the soil, the material does not appear to be pressure treated or naturally decay resistant- recommend repair. If not corrected- overtime the wooden members will decay.

1. Areas below the wood steps at the N side- Lower level steps. See prior pics.
2. Two wooden supports were noted in contact with soils under the lower height NW porch area near the lower level N side door. Past repair were noted. (Some newer wood with metal brackets)
3. Areas adjacent to this area of the wood porch are in contact with rock and soils it appears and will require ongoing attention.

Contact a qualified professional.

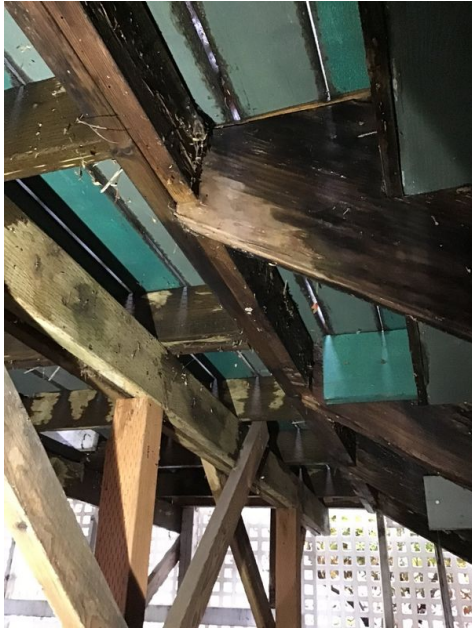
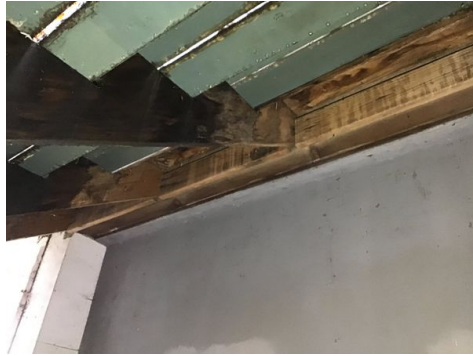
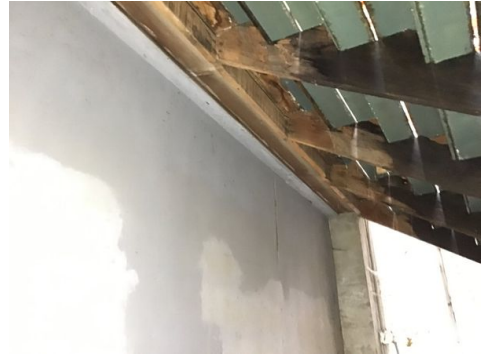
DECK-HARDWARE RECOMMENDED

Recommend installing hardware on the post and beam connections for the porch/stair framing. Consider updates to newer seismic standards. A licensed decking contractor can offer a final determination of attention needed.

Contact a qualified deck contractor.

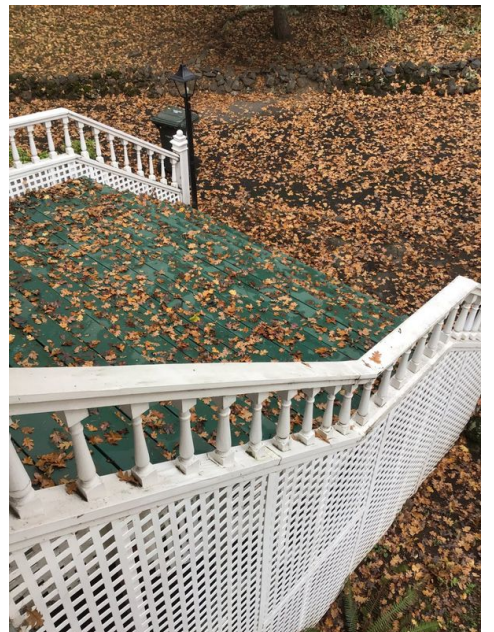
GUARD RAILING LOOSE / LOW IN HEIGHT-

Guard railing was loose recommend repair by a licensed carpenter. Noted to move when leaned upon. Updates are needed for occupant safety. See prior notes.

Contact a qualified deck contractor.

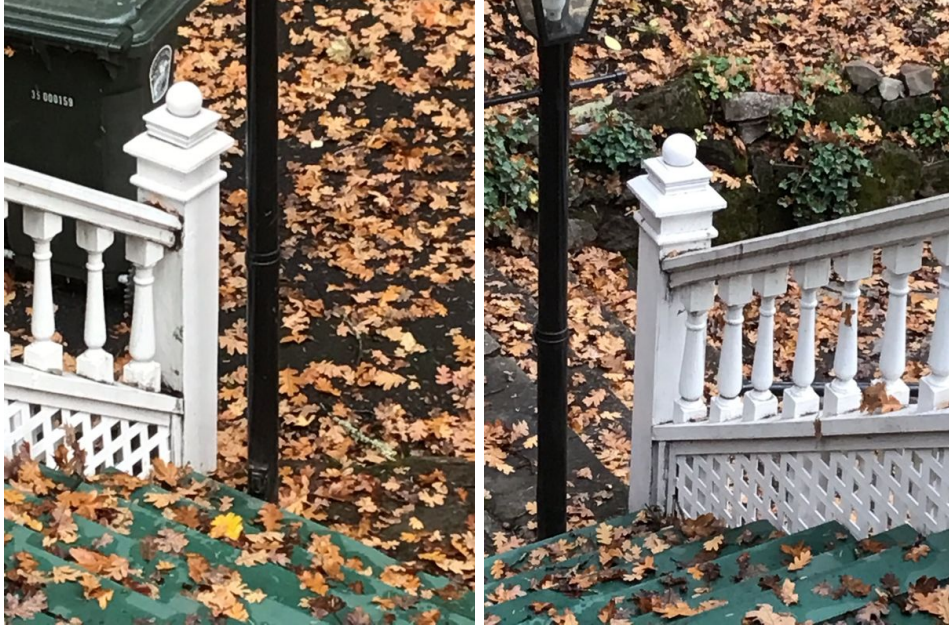
LOOSE PORCH POST

The post installed on the porch is loose recommend further review and repair by a licensed general contractor.

Contact a qualified general contractor.

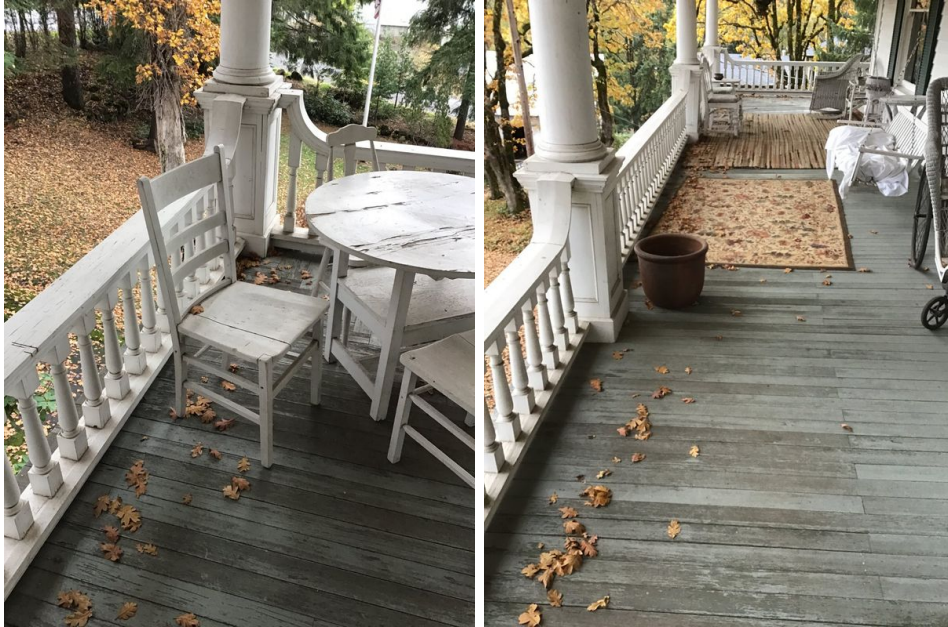
IMPROPER GUARDRAIL HEIGHT (NOT 36")

I observed indications of a defect related to the height of a guardrail.

Correction and further evaluation is recommended.

Contact a qualified carpenter.
