**ORIGINAL HOME
INSPECTION
SUMMARY**

245 W Jewett Blvd, White Salmon WA
98672
Marla Keethler
October 29, 2021

Steve Gibson
Certified Real Estate Inspector Since 1998
InterNACHI 12041805 | Washington #
379 Oregon # 76 - Licensed Construction
Contractor # 129290
Buyers & Sellers Home Inspection Service

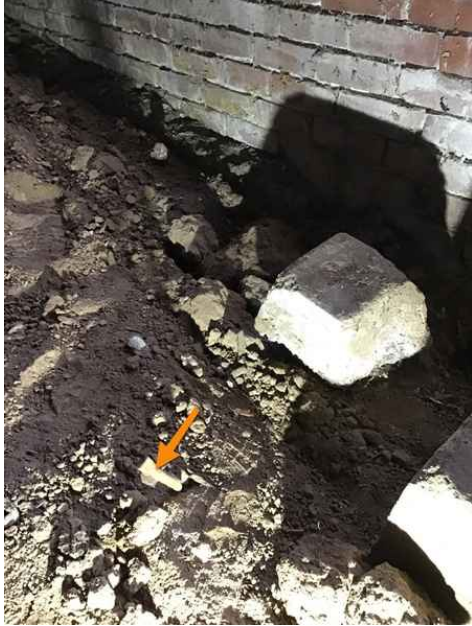
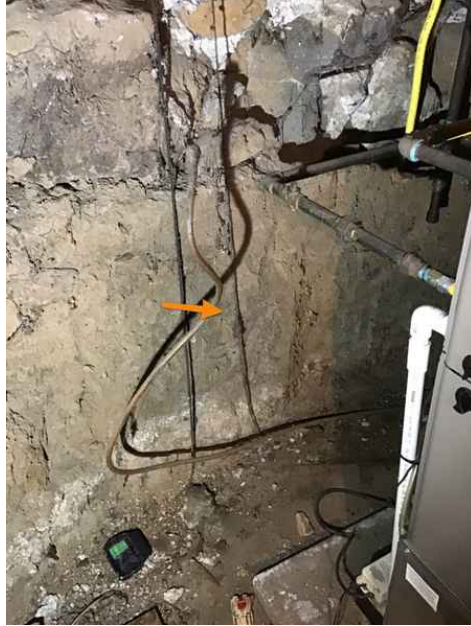
3.12.1 Copper pipe visible - east side

Contact a qualified professional.

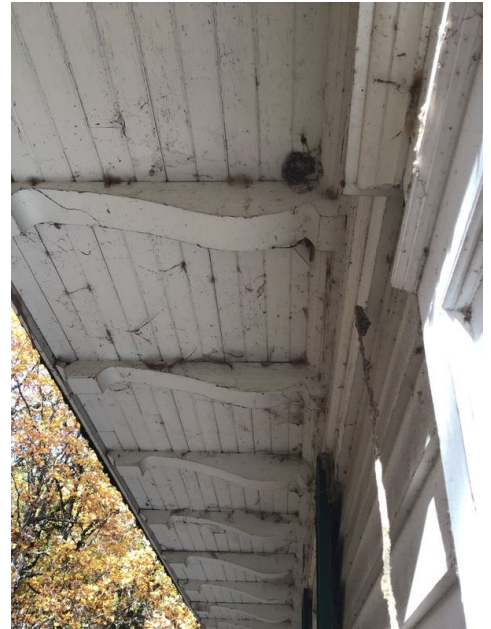
3.13.1 Minor cleaning needed - west side

Contact a qualified professional.

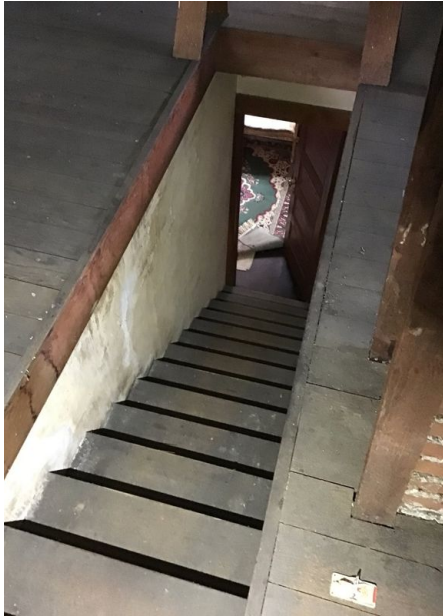
Main upper attic vie of the stairway - narrow

Hand railings suggested at the attic steps. The upper most flat roof area was not safely accessible thus excluded.

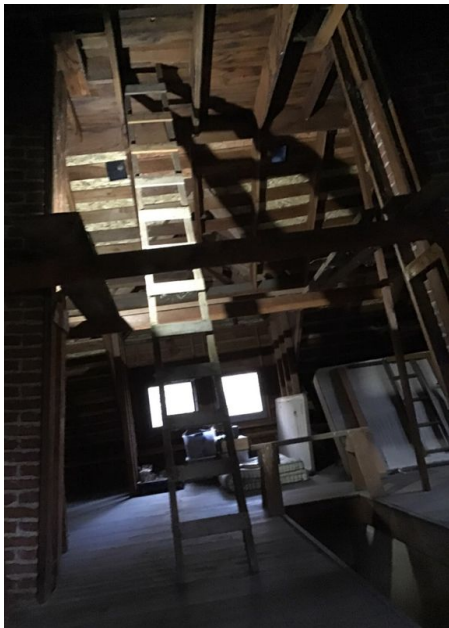
Unsafe ladder access to flat portion fo the roof- excluded- not inspected.

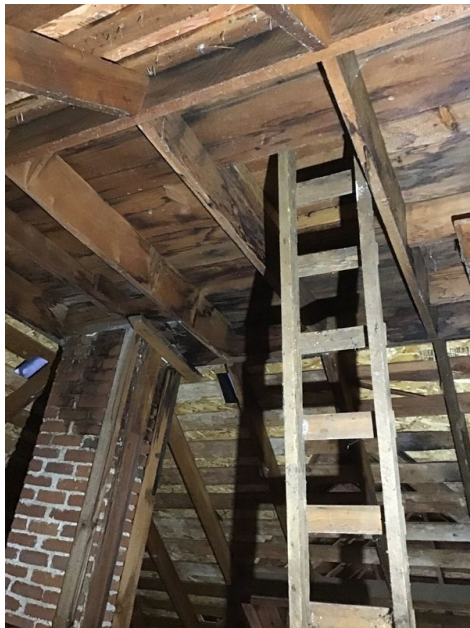
Indications of past leaking noted- None at the time of the inspection.

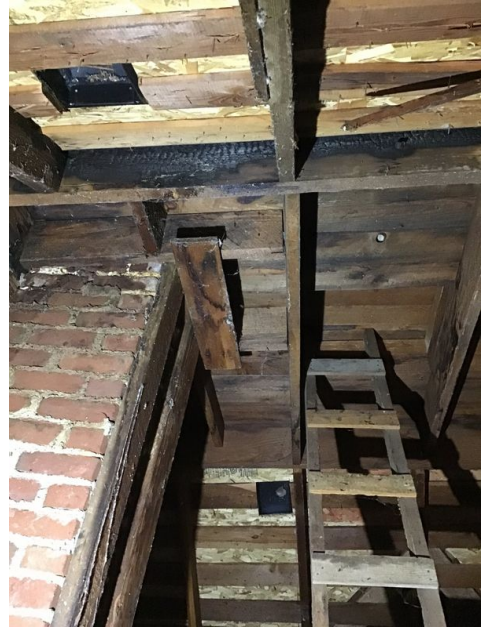
PAST FIRE INDICATIONS NOTED

Contact a qualified professional.

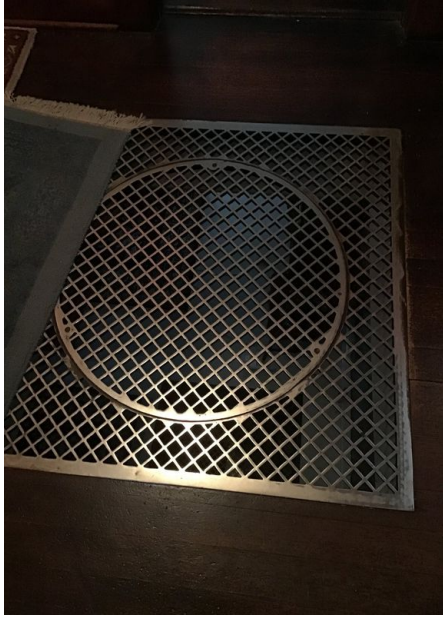
Lowest living level -

I observed that the thermostat is very old and should be upgraded to a modern energy-efficient thermostat. Also it was noted that the thermostat is located on the lower level / next to the freestanding gas unit - the tempature of the main level likely will be less given the location of the open heat source with out common duct work. An HVAC professional can offer more information as to the best future location of a thermostat for the lower furnace.

Recommended DIY Project

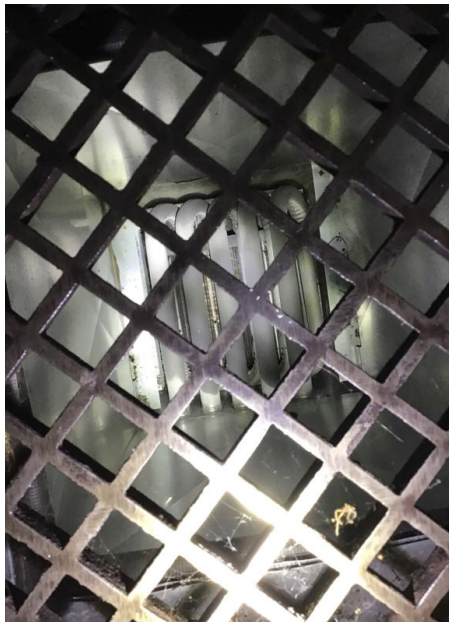
One lowest level gas furnace and a lower level free standing gas unit.

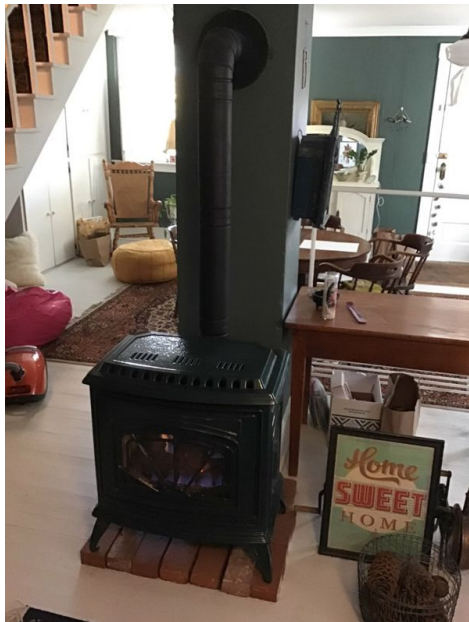
ONE CENTRAL heat source- No Duct work in the home to each room -

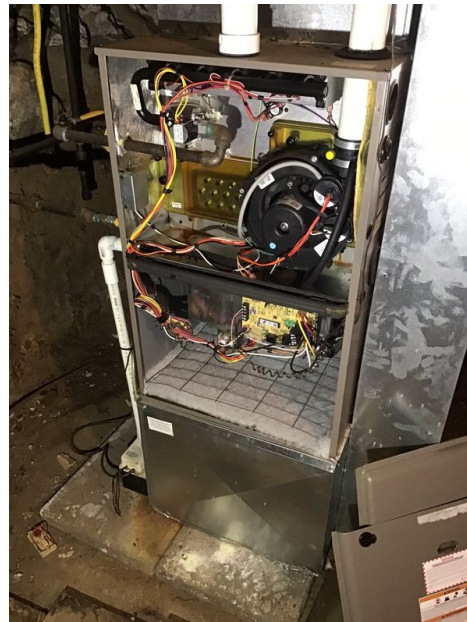
Lower level unit - Appears to function

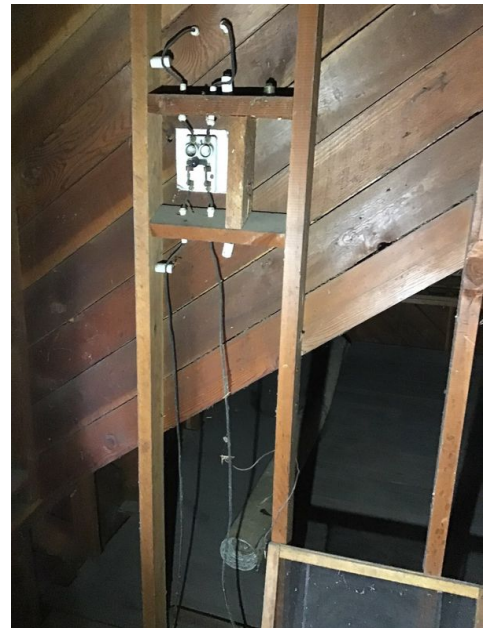
I observed exposed live AGED FUSE SYSTEM and aged electrical wires that appears still in use. Updates are warranted. Suggest a licensed electrician review the structures eletrical systems for a final determination of attention needed for occupant safety.

Contact a qualified electrical contractor.

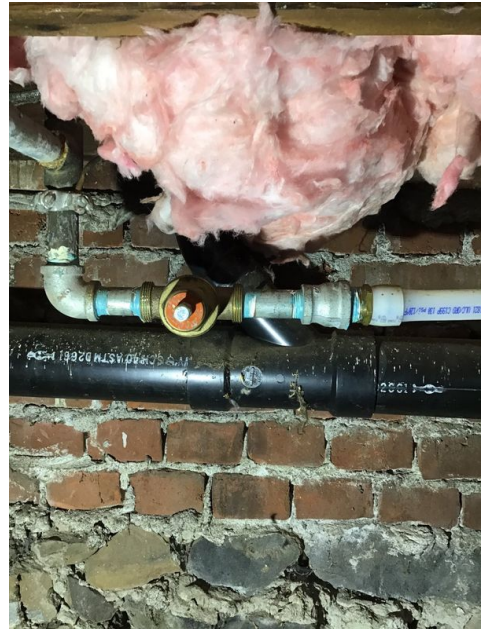
UNABLE TO CONFIRM PRESENCE OF GROUNDED CONDUCTOR

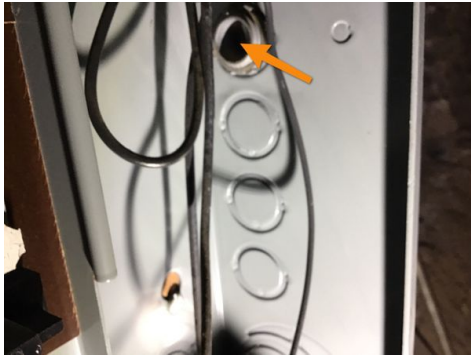
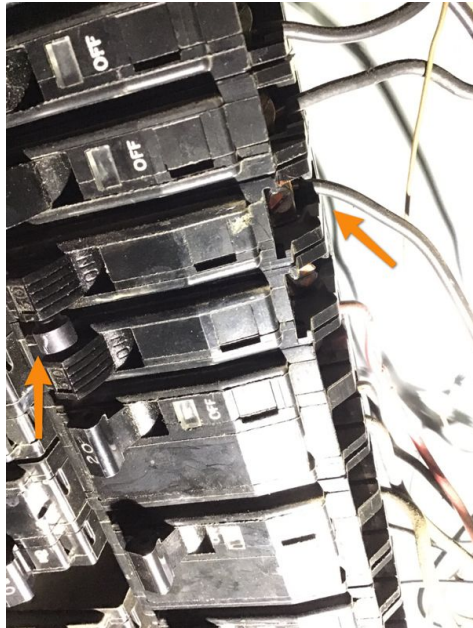
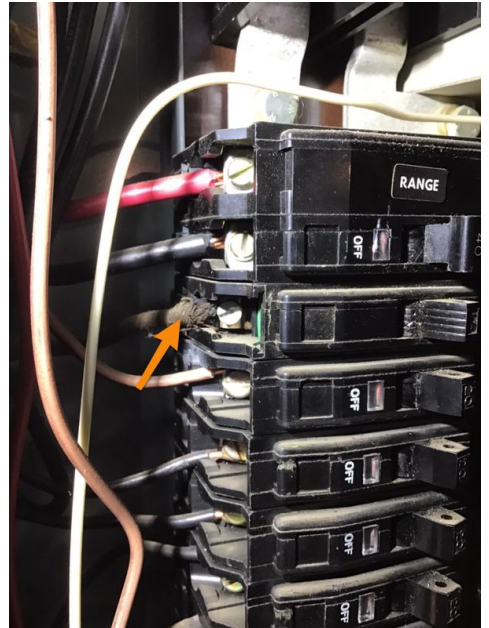
Limited views were obtained in many areas of the period home due to storage including in the basement. Areas of visible period knob and tube wiring were noted along side some joists that may be still in use. Suggest a licensed electrician review the full basement and attic areas for wiring that is accessible and requires updating. Commonly in areas where knob and tube wiring is accessible it is updated.

Contact a qualified electrical contractor.

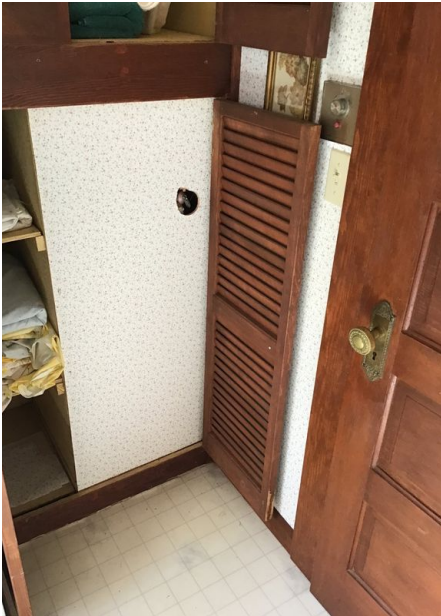
Upper unit not accessible fixed covering

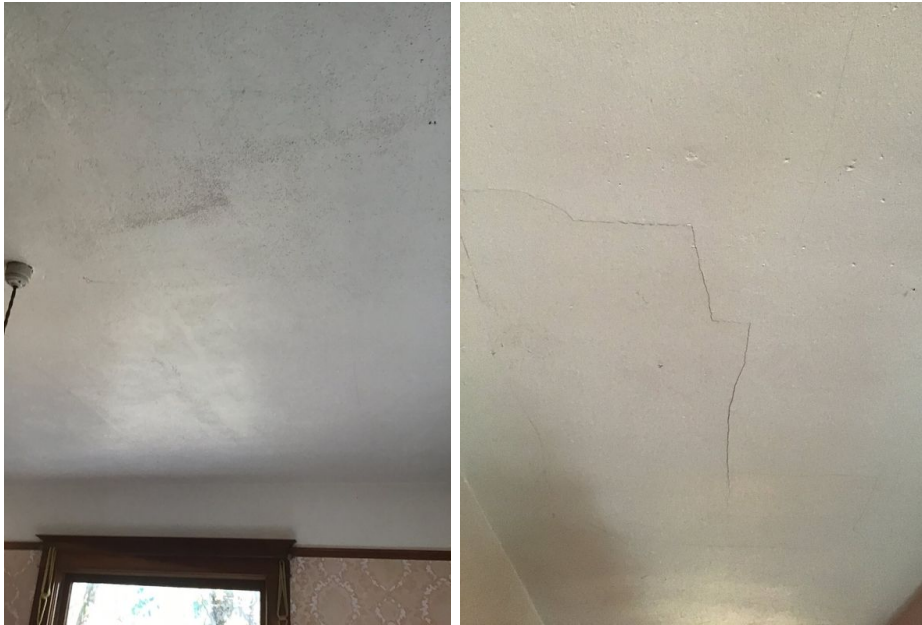
Some cracks noted- minor. See other notes.

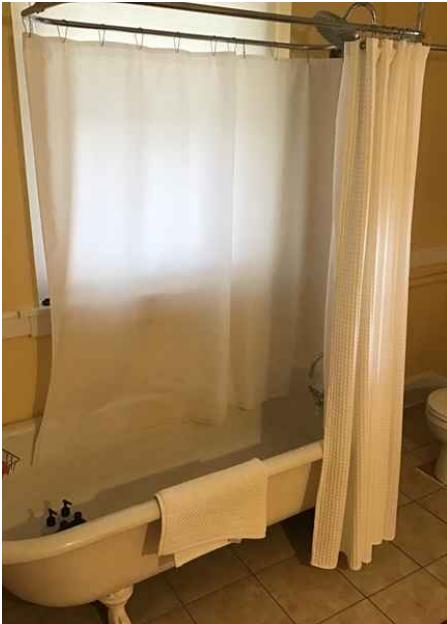
Period Clawfoot tub with added shower- Lowest level bath.

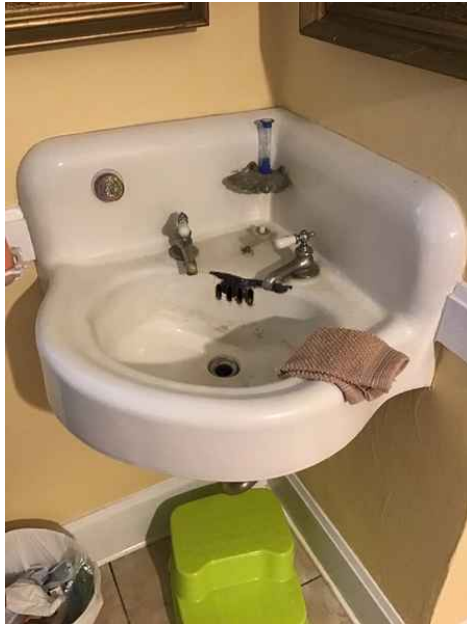
Older corner sink with damage (chipped) noted. No shut off valves noted below the sink.

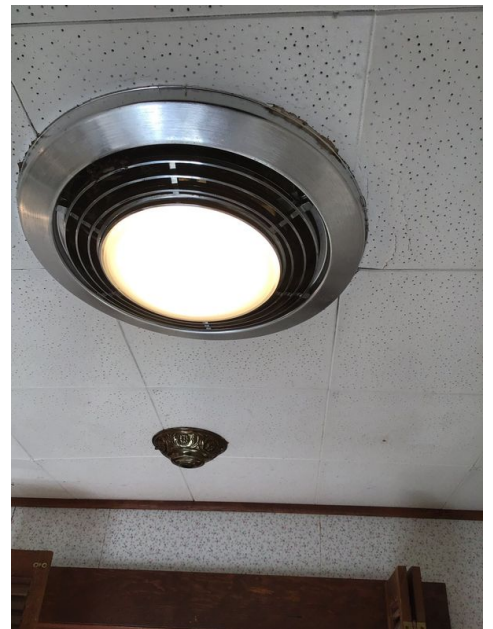
HEAT LAMP DEFECT

I observed that the heat lamp fixture in the bathroom did not work. The fan made a rattle noise- likely not fully functional. Unable to determine if the fan is ducted to the exterior vs. just inside the small shed attic space above.

Aged unit updating is suggested

Contact a qualified electrical contractor.

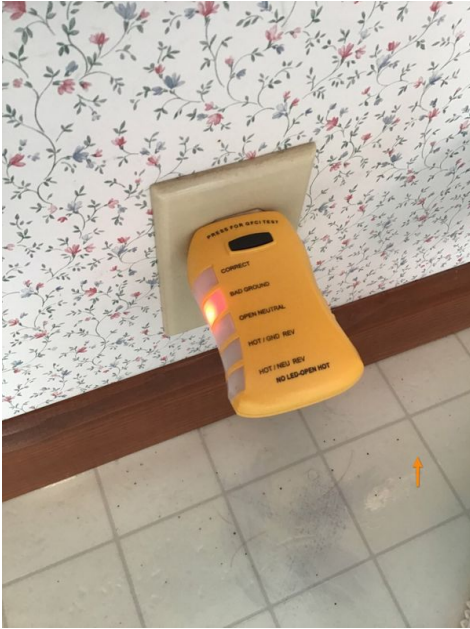
I observed that the receptacle in the bathroom is not testing as being GFCI protected. This is a hazardous condition. All baths could use GFCI updates. Dated two pronged outlets noted in many locations within the home.

Non grounded outlet near the tub below the window-

Contact a qualified electrical contractor.

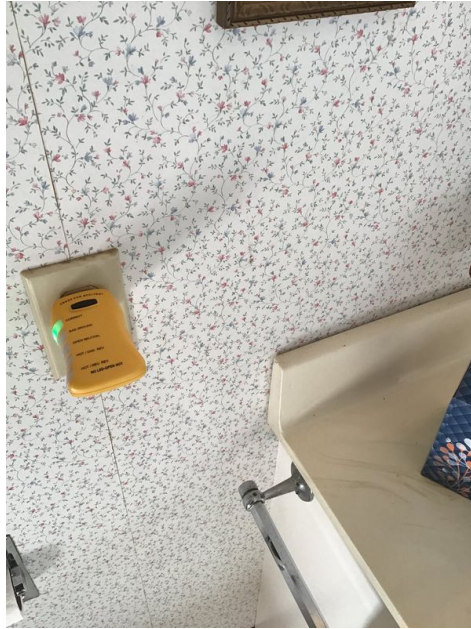
GFCI needed

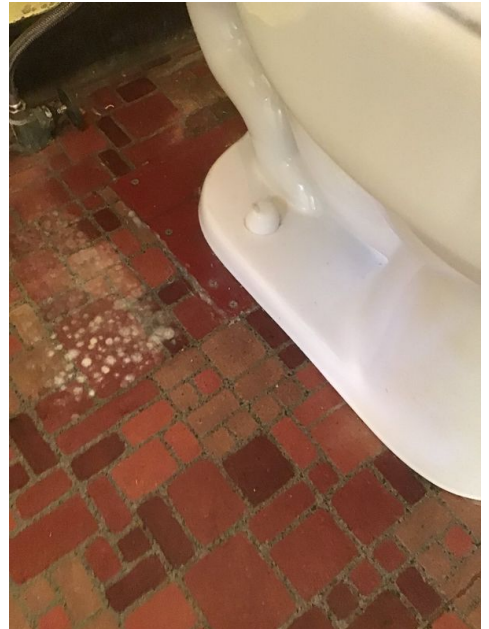
FLOOR DAMAGE

I observed damage at the bathroom floor. All three bath areas have aged flooring with repairs. Ongoing caulking and touch up will likely be needed.

Past repairs noted

Contact a qualified handyman.

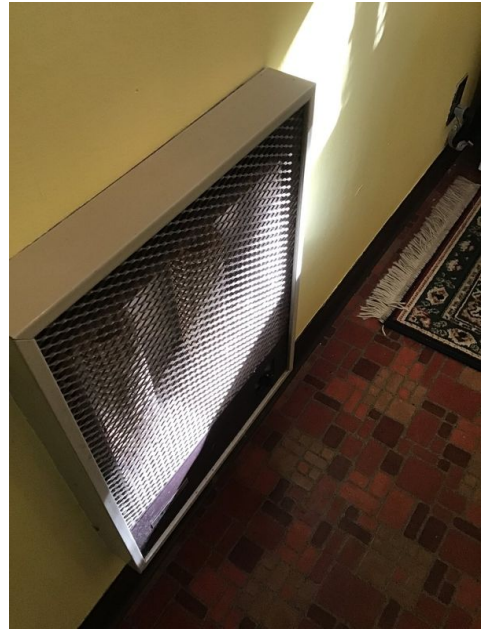
13.2.2 Two pronged dated outlet
**DATED WALL HEATER FOR
UPDATING**

Contact a qualified electrical contractor.

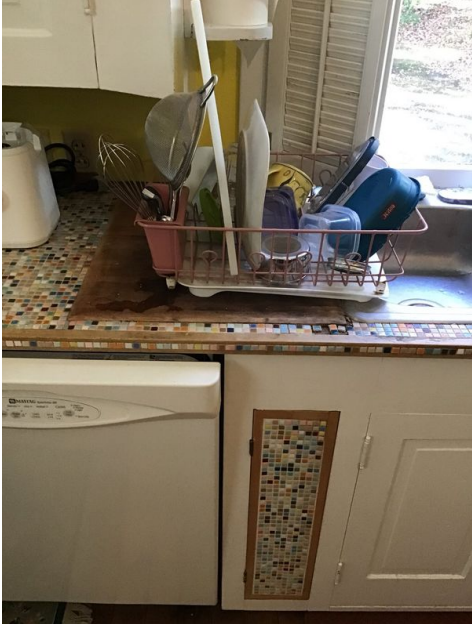
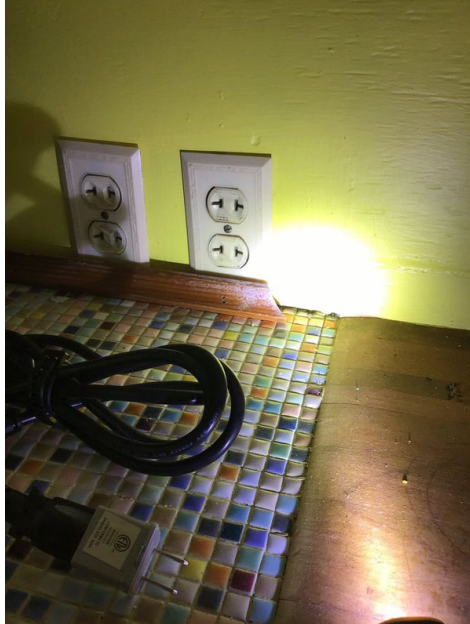
MISSING GFCI PROTECTION

I observed indications of missing GFCI protection in the kitchen. All kitchen counter receptacles are required to be GFCI protected.

Contact a qualified electrical contractor.

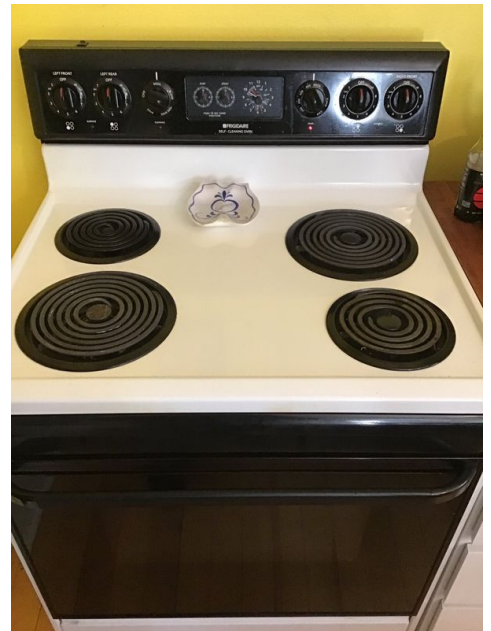
MISSING ANTI-TIP

I observed that the stove and oven appliance was not fastened to the floor. Anti-tip device is missing. This poses a safety hazard to children.

Contact a qualified professional.

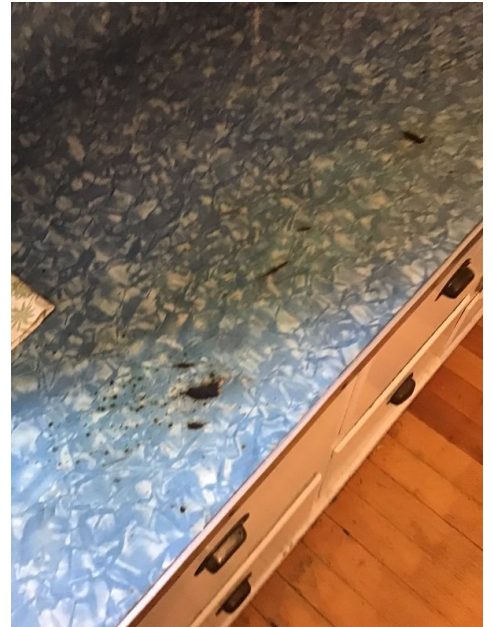
WORN AREAS AT COUNTERTOPS

I observed worn areas and some damage at the countertops.

Recommend monitoring.

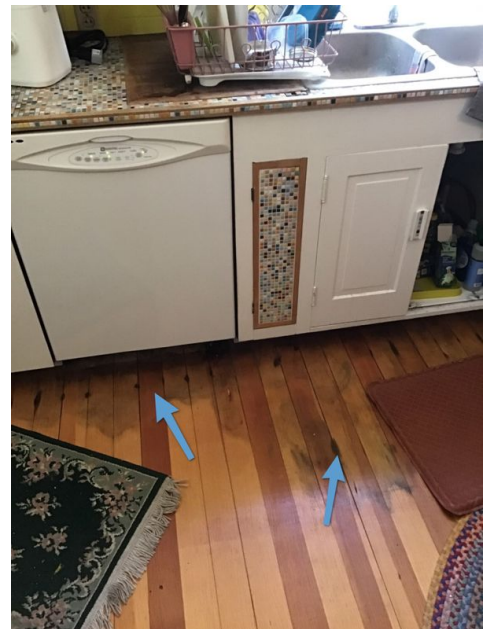
MOISTURE DAMAGE

Stains on the walls visible at the time of the inspection appeared to be the result of moisture intrusion. The source of moisture may have been corrected. Recommend further examination by a qualified contractor to provide confirmation or inquire with the seller.

Contact a qualified professional.

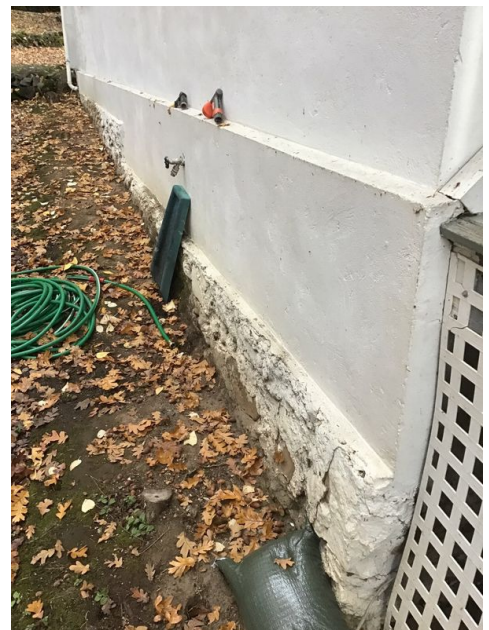
West side foundation area-

WINDOW SYSTEMS NOTED IN THE BASEMENT THAT COULD BE SCREENED TO AID IN THE VENTING THE SUB AREA.

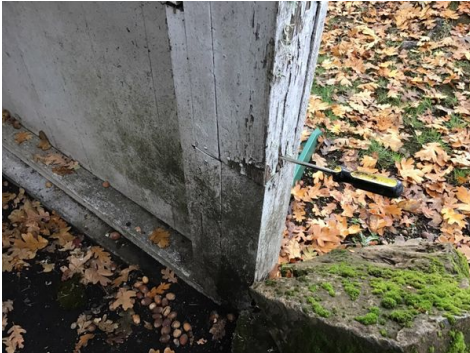
Southwest corner Wood Decay

Contact a qualified general contractor.

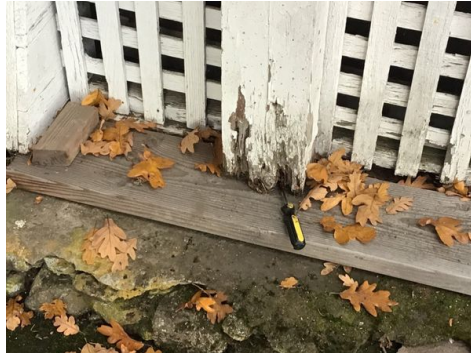
Northeast Side- Post floating and damaged

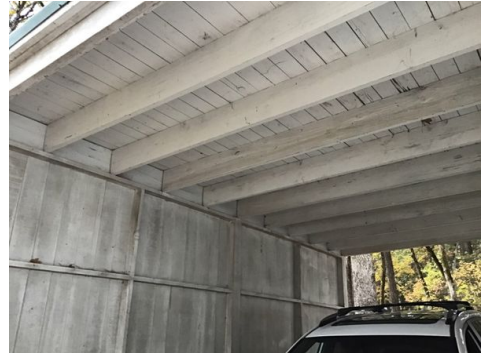
No diagonal support work and or metal supports

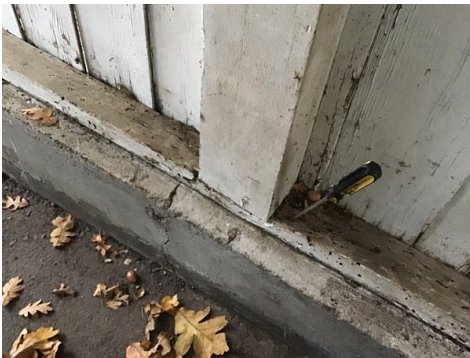
South

I observed structural defects at the carport. This was noted as secured some to the main structure in only a few locations with metal anchors - but it appears that updates and repairs are warranted. A licensed contractor and or structural engineer is suggested for a final determination of attention needed.
