# **FEASIBILITY STUDY**

# 1.0 - EXECUTIVE SUMMARY

The Walker House is a historic dwelling set amid an idyllic, wooded site in White Salmon, WA. This study examines the feasibility of modifying the building to become a central gathering place for the community. With proposed programs that include rental space for meetings, artist residencies, retail, and seasonal uses such as an ice cream parlor and wedding venue, the reimagined Walker House would result in a change of occupancy, which, in turn, would require several coderelated upgrades.

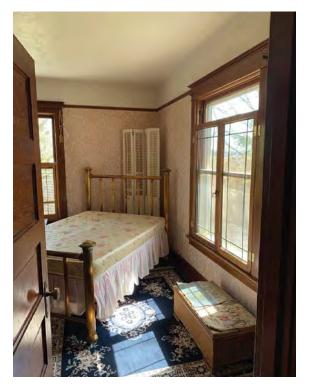
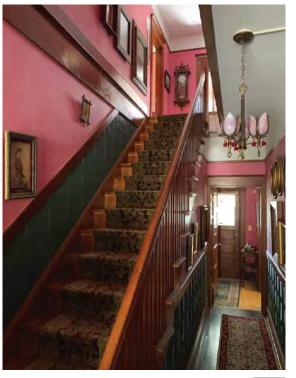
The guard railings along the north entry steps, main floor porch, and lower level porch are in need of updates to meet current height requirement of 42 inches above finished floor. The spacing between rails exceeds the 4-inch maximum allowed. Furthermore, the stair railings are not secured fully and move with ease. A handrail on the north stair needs to be added to one side; at the south stair, guardrails and a handrail need to be added on one side. The interior stairway is in need of code-compliant handrails and updates to guardrails to meet current height and spacing requirements.

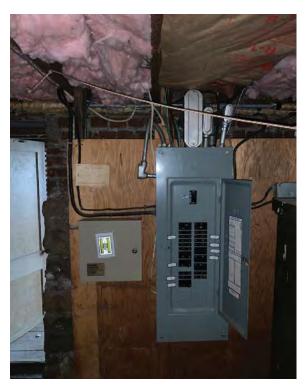
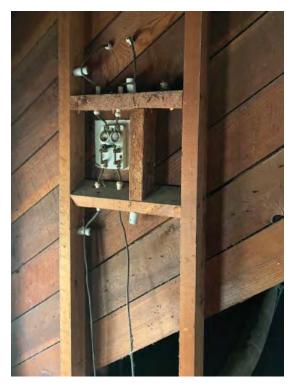
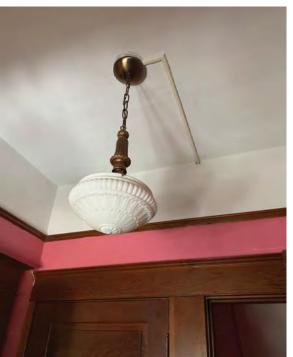
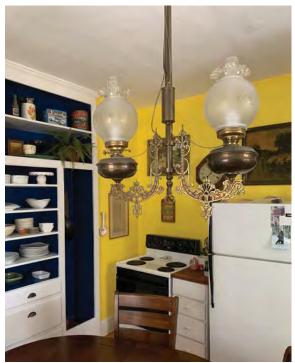
All lighting will need to be brought up to energy code compliance. Light fixtures must be replaced with LED models, light levels need to be verified, and occupancy sensors added.
